# New Construction Pre-Drywall Inspection

**Lot 60A, 1234 First Street**

**Date of Inspection: 8/21/2013**

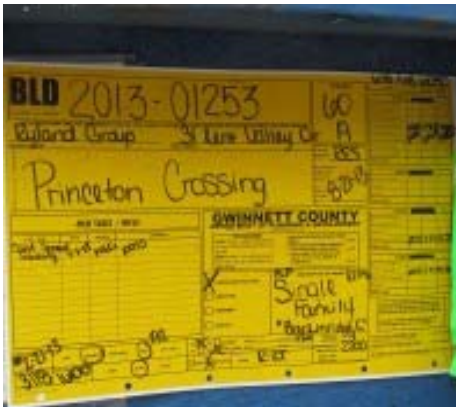
C.1

Line No.	Item Description	Action Needed	See Photo
C . 1	Photo of the Gwinnett County Building permit - 2013 codes apply.	<input type="checkbox"/>	<input checked="" type="checkbox"/>
C . 2	<p>It appears that loosely compacted fill dirt has been placed to the East of the dwelling and it was not possible to confirm at the time of the inspection if this fill material was properly compacted in engineered lifts under the foundation walls and basement slab on grade as required by code Section R403 FOOTINGS R403.1 "Footings shall be supported on undisturbed natural soils or engineered fill." Builder should provide confirmation that the dwelling footings were placed on "undisturbed natural soils" or provide of a PE's soil compaction reports for any "engineered fill".</p> <p>Also, the sloped bank has significant soil erosion and no visible ground cover which should be installed prior to dwelling completion.</p>	<input checked="" type="checkbox"/>	<input checked="" type="checkbox"/>

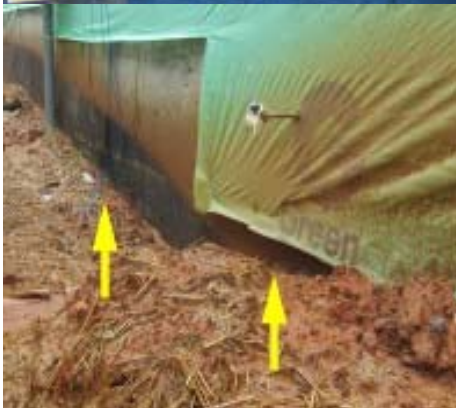
C.3

| C . 3 | No brick ledge was found formed into the concrete foundation walls as required by code to properly support the weight of the exterior brick veneer. See attached Figure R703.7 "Masonry Veneer Wall Details" page 236 of the 2006 IRC. Also, the fill dirt placed against these foundation walls is saturated with water and does not appear to be properly compacted and capable of supporting the brick veneer as required by code. Footings and/or compacted fill do not appear to comply with the International Residential Code - SECTION R403 FOOTINGS R403.1 General. All exterior walls shall be supported on continuous solid or fully grouted masonry or concrete footings, wood foundations, or other approved structural systems which shall be of sufficient design to accommodate all loads according to Section R301 and to transmit the resulting loads to the soil within the limitations as determined from the character of the soil. Footings shall be supported on undisturbed natural soils or engineered fill. | <input checked="" type="checkbox"/> | <input checked="" type="checkbox"/> |

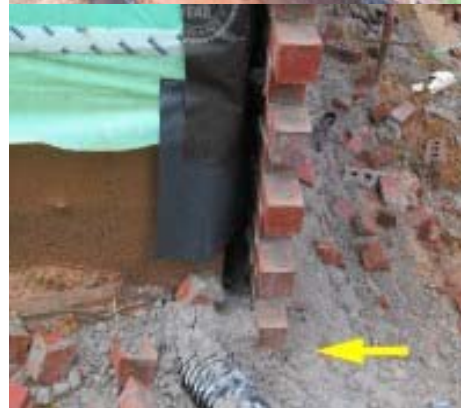
C.4

| C . 4 | Photo of the brick ledge being installed on soft wet poorly compacted earth for the dwelling to the North of Lot 60A. This brick ledge appears to be constructed of loosely placed mortar and not concrete that has been properly keyed or doweled into the dwelling foundations. This is a poor construction practice and should not be used for the dwelling constructed on Lot 60A. | <input checked="" type="checkbox"/> | <input checked="" type="checkbox"/> |

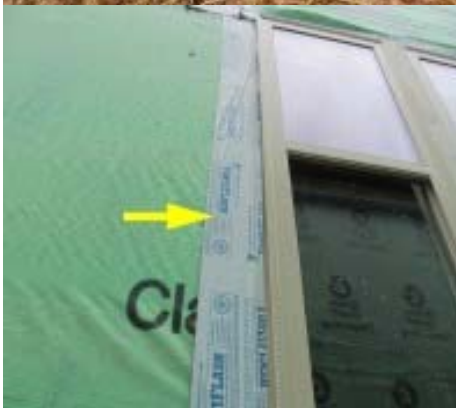
C.5

| C . 5 | Peal stick flashing has been installed around the exterior doors and windows; however, it is lifting and should be properly adhered/sealed to the building wrap. | <input checked="" type="checkbox"/> | <input checked="" type="checkbox"/> |

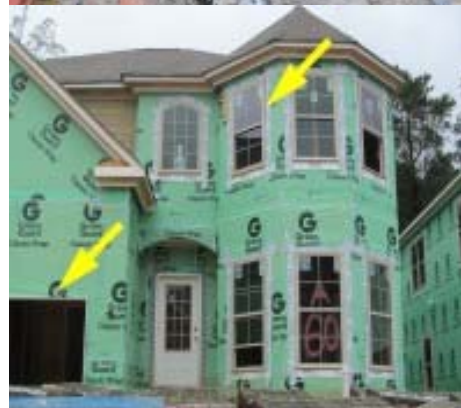
C.6

| C . 6 | The brick veneer has not yet been installed. All brick above window and door openings AND above any roof slopes should be properly supported by suitable steel lintels. Lintels used for supporting brick veneer above a roof slope must be properly bolted to the wood structural framing per 2006 IRC, Section R703.7.2.2 "Support by roof construction". | <input checked="" type="checkbox"/> | <input checked="" type="checkbox"/> |

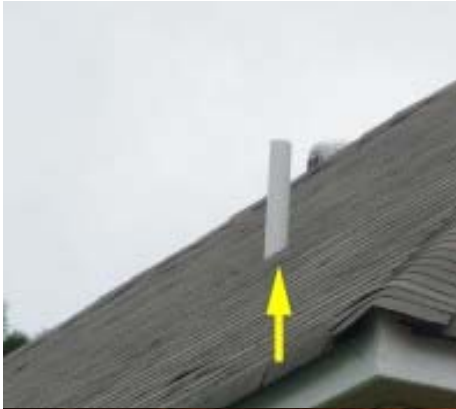
C.7

| C . 7 | Roof vent boot flashings have not been installed and should be to eliminate leaks. | <input checked="" type="checkbox"/> | <input checked="" type="checkbox"/> |

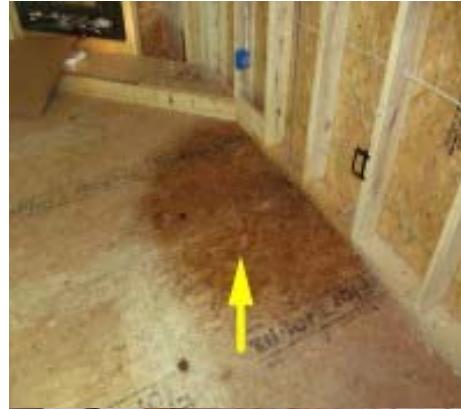
C.8

| C . 8 | All of the plumbing roof vents were leaking and water is ponding on the floor decking in numerous locations. Once the boot flashings are properly installed and sealed, this decking should be properly dried, any possible mold/mildew eliminated, and if necessary sanded prior to installing any finished flooring in these areas. | <input checked="" type="checkbox"/> | <input checked="" type="checkbox"/> |

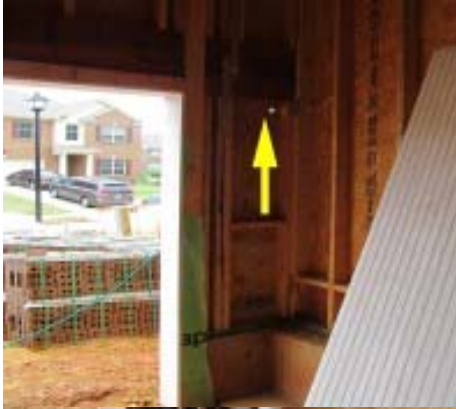
C.9

| C . 9 | The narrow wall bracing on each side of the garage door appears to comply with code - except as stated in C.10 below. Exterior nailing pattern of the wood sheathing was covered by the building wrap and not visible for inspection. | <input type="checkbox"/> | <input checked="" type="checkbox"/> |

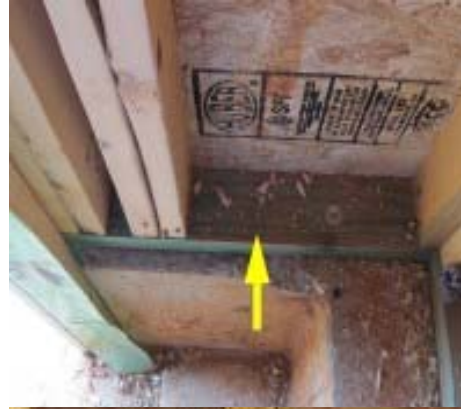
C.10

| | <p>No anchor bolts were visible in the two garage narrow walls as required by the Georgia Amendment to the 2006 IRC. Bolts should be properly installed.<br/>"R602.10.5 Continuous structural panel sheathing. When continuous wood structural panel sheathing is provided in accordance with Method 3 of Section R602.10.3, including areas above and below openings, braced wall panel lengths shall be in accordance with Table R602.10.5. Wood structural panel sheathing at corners shall be installed in accordance with Figure R602.10.5. ... Two anchor bolts shall be installed in accordance with Section R403.1.6, and plate washers shall be a minimum of 2 inches by 2 inches by 3/16 inches (51 mm by 51 mm by 4.76 mm) thick and shall be used on each bolt. This exception is only permitted in Seismic Design Categories A-C."<br/>(Effective January 1, 2007)</p> | | |

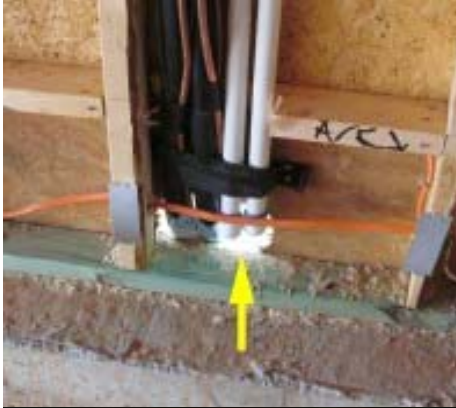
C.11

| C . 11 | Dwelling should be properly sealed to comply with the requirements of the 2009 International Energy Conservation Code and the Georgia Amendments, including APPENDIX A AIR SEALING KEY POINTS (see attached copy). | <input checked="" type="checkbox"/> | <input checked="" type="checkbox"/> |
| | <p>Numerous holes in the dwelling exterior have not yet been sealed as required by the 2009 IECC and should be.</p> | | |

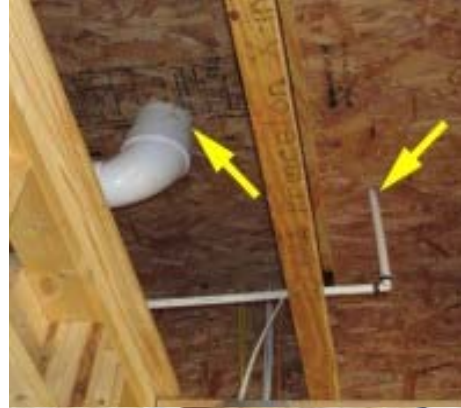
C.12

| | <p>Gaps around all plumbing and duct penetrations from one level of the dwelling to another should be properly insulated and sealed as required by the 2006 IRC requirements for fire blocking and the 2009 International Energy Conservation Code and the Georgia Amendments, including APPENDIX A (see attached).</p> | | |

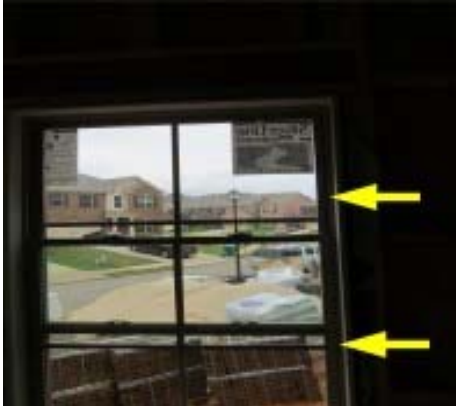
C.13

| | <p>Gaps around all exterior windows and doors should be properly insulated and sealed as required by the 2009 International Energy Conservation Code and the Georgia Amendments, including APPENDIX A (see attached).</p> | | |

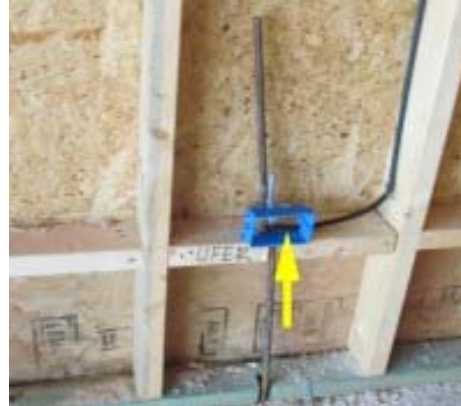
C.14

| | <p>The Uffer grounding connection for the dwelling electrical grounding system is located on the North garage wall and it appears that the Builder is going to provide access to it as required by code.</p> | | |

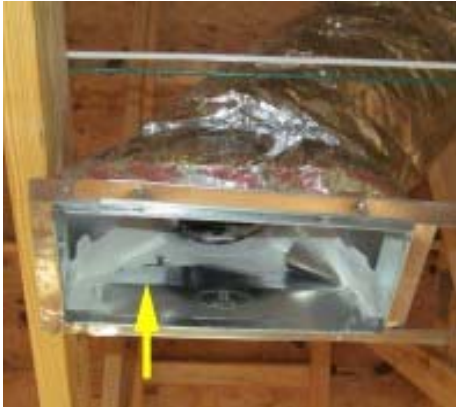
C.15

| | <p>Mastic has been used to seal duct connections and register housings as required by code.</p> | | |

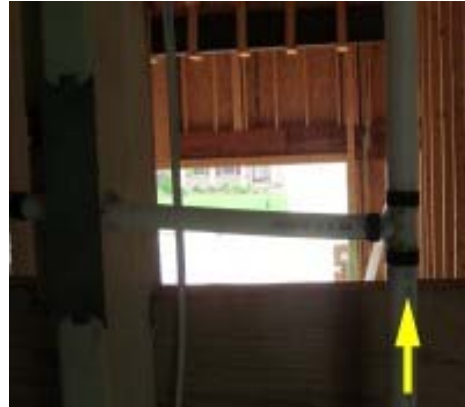
C.16

| | <p>Water distribution piping material is PEX and was being pressure tested at the time of the inspection. Drainage plumbing is PVC and purple primer is visible on the connections as required by code.</p> | | |

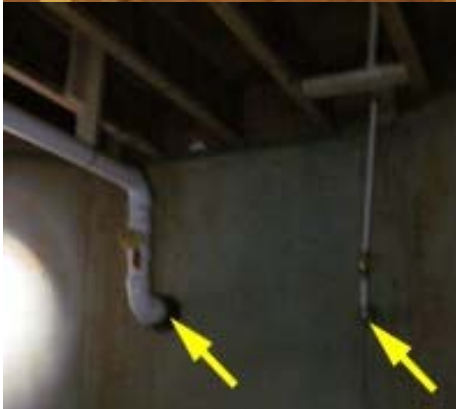
C.17

| | <p>Wall penetrations for the plumbing lines in the West basement foundation wall appear to be leaking and should be properly sealed.</p> | | |

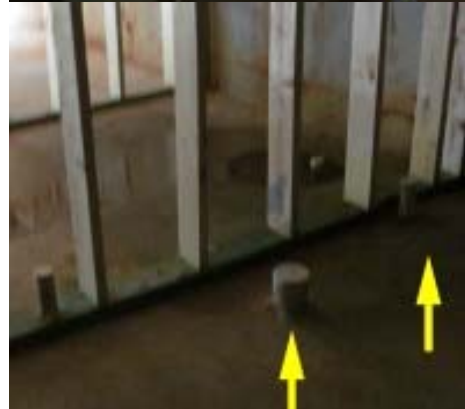
C.18

- C . 18    
The Homebuyer believes that the stub up for the basement bath toilet and tub should be on the East side of the studded wall near the crock for the grinder pump. The Homebuyer has requested that these stub ups be relocated. (Since the location of the crock is near the South foundation wall - perhaps it can be enclosed inside a closet if this smaller framed area is to become the bathroom.)

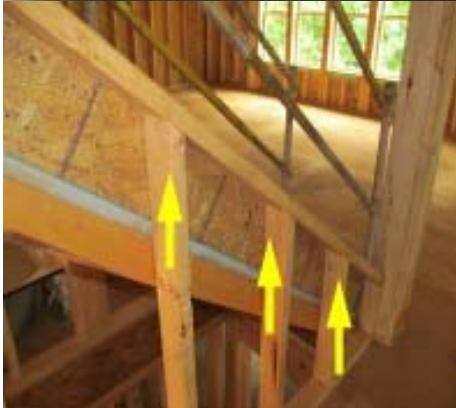
C.19

- C . 19    
Most manufacturers of prefabricated stairs require that the stairs be properly shimmed and nailed to EACH wall stud in order to not void the manufacturer's warranty (and to assure stairs will not squeak over time). Stairs should be properly shimmed and fasteners installed at each wall stud.

- Stairs are NOT nailed at every stud and should be.
- C . 20    
Roof support structure system is 2X4 trusses -- trusses appear to be installed vertically, no loose connection plates were visible, no field cuts and no broken cords were found. Homebuyer should store only light weight items that heat will not damage in the attic and limit the weight of any items stored in the attic in order to not damage the trusses. Truss roof systems are designed to support ONE layer of roof shingles, the roof decking, and the dry wall ceilings below.

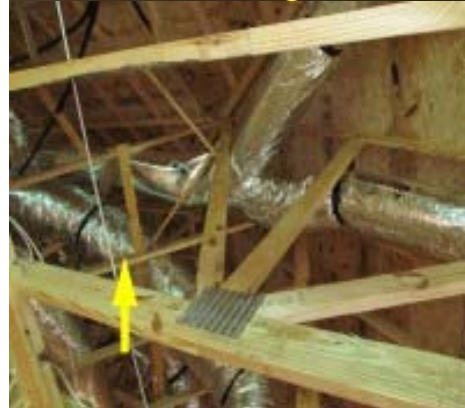
C.20

- Hurricane ties are installed and appear to be adequately nailed.
- C . 21    
Sheathing was installed behind the tub for the Jack and Jill bath and it was not possible to confirm that insulation is installed behind the sheathing. Builder should confirm that insulation was installed above and below the tub.

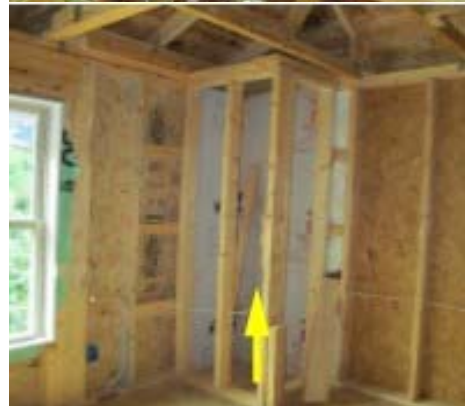
C.22

- C . 22    
A framed chase is installed in the SE corner of the Master Bedroom. Builder should explain the purpose for this space?
- C . 23    
No suitable shower pan liner was installed for the Master shower at the time of the inspection. One should be installed and properly tested for leaks.

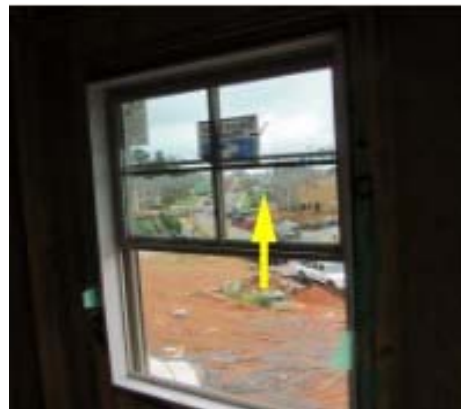
C.24

- C . 24    
Broken upstairs window near the SW corner of the dwelling should be replaced.
- C . 25    
The Homebuyer requests that the Builder advise why a window is not installed near the SW corner of the Kitchen as it shows on the Kitchen cabinet drawing for this wall? (Drawing was found on the floor of the Kitchen at the time of the inspection.)
