# Home Inspection

**Mr. Charles R. Smith**

**1234 First Street**

**Date of Inspection: 5/6/2013**

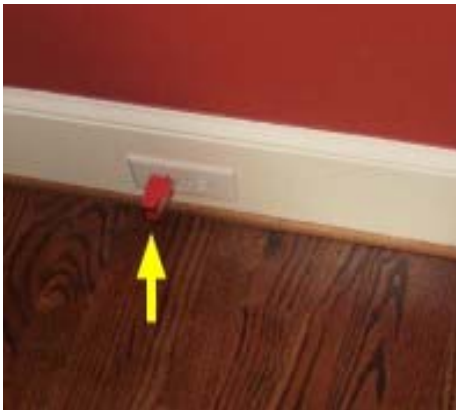
Line No.	Item Description	Action Needed	See Photo
1 . 1	The electrical receptacles on the North wall of the main level Study are not operating and should be properly repaired.	<input checked="" type="checkbox"/>	<input checked="" type="checkbox"/>
1 . 2	Same as 1.1 above - except only 1/2 of the duplex receptacles on the South wall of the Study are operating and should be properly repaired.	<input checked="" type="checkbox"/>	<input checked="" type="checkbox"/>

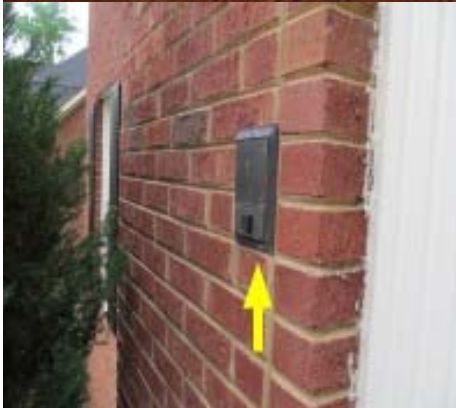
1.3

| 1 . 3 | Front doorbell was not operating at the time of the inspection and should be repaired. Also, the rain proof cover for the front door electrical receptacle is loose and should be properly secured and sealed to prevent water intrusion. | <input checked="" type="checkbox"/> | <input checked="" type="checkbox"/> |

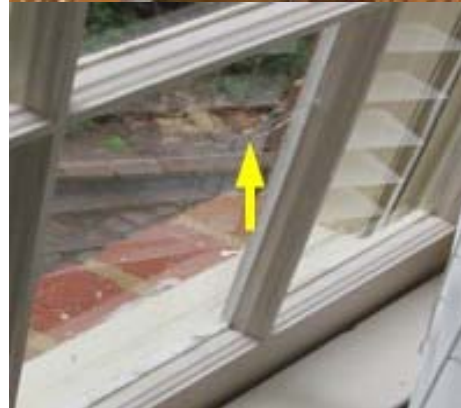
1.4

| 1 . 4 | Cracked window pane on NW Family Room window should be replaced. | <input checked="" type="checkbox"/> | <input checked="" type="checkbox"/> |

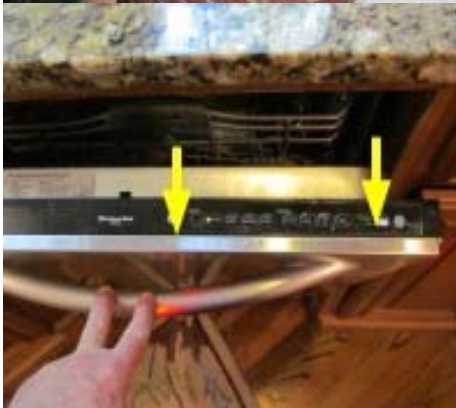
1.5

| 1 . 5 | The membrane cover that protects the switches for the dishwasher controls is damaged in two places and should be properly repaired/sealed or replaced. | <input checked="" type="checkbox"/> | <input checked="" type="checkbox"/> |

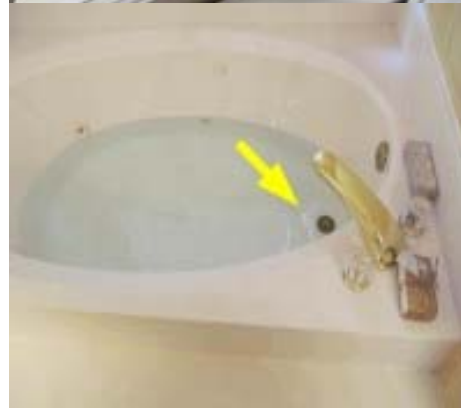
1.6

| 1 . 6 | The seal for the stopper in the Master Bath tub is not holding and should be replaced. | <input checked="" type="checkbox"/> | <input checked="" type="checkbox"/> |

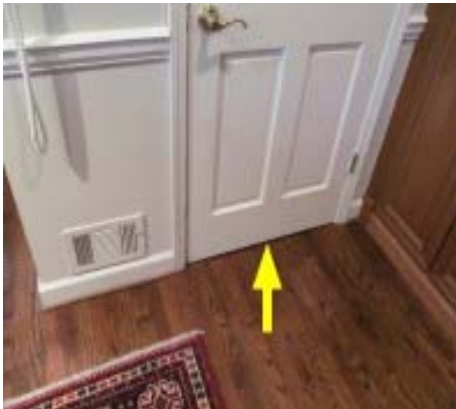
1.7

| 1 . 7 | Lower edge of the door to the Laundry Room is too low and should be cut and raised to provide an approximate 3/4 inch gap so that adequate supply air is available to the clothes dryer when the door is closed. | <input checked="" type="checkbox"/> | <input checked="" type="checkbox"/> |

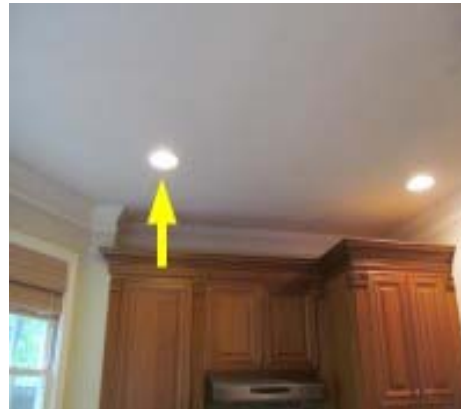
1.8

| 1 . 8 | One of the Kitchen ceiling light lamps was flickering ON and OFF numerous times until the dimmer was adjusted. Perhaps the lamp is defective and should be replaced? The light fixture should be repaired to operate properly. | <input checked="" type="checkbox"/> | <input checked="" type="checkbox"/> |

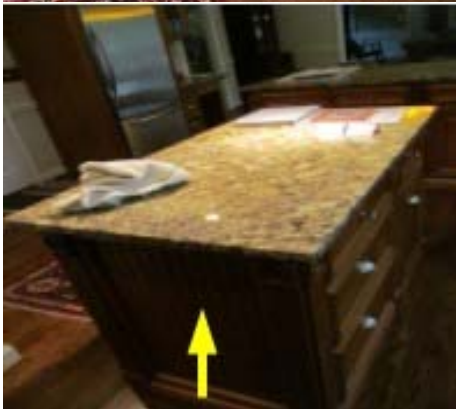
1.9

| 1 . 9 | No receptacle was found for the Kitchen island and one should have been installed as required by code. | <input type="checkbox"/> | <input checked="" type="checkbox"/> |

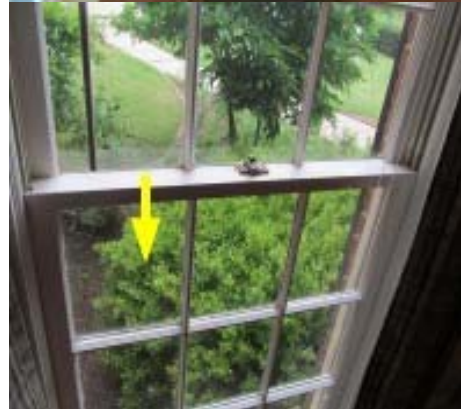
1.10

| 1 . 10 | <p>Windows are stuck and do not open (probably due to excessive paint or plastic guides sticking to the wood sashes -- if plastic guides are sticking usually silicone spray can be applied to the guides and wiped from an other surfaces to help reduce sticking). Windows should be freed to provide a means of emergency exit in case of fire.</p> <p>Windows are single pane wood frame windows and appear to be in acceptable condition at the time of the inspection. The following windows are stuck and should be freed:</p> <ul style="list-style-type: none"> <li>- 2 ea Dining Room</li> <li>- Study</li> <li>- Garage</li> <li>- Family Room</li> <li>- 2 ea Upstairs South Bedroom</li> <li>- Upstairs West Bedroom</li> <li>- Master Bath</li> <li>- Basement Family room</li> </ul> | <input checked="" type="checkbox"/> | <input checked="" type="checkbox"/> |

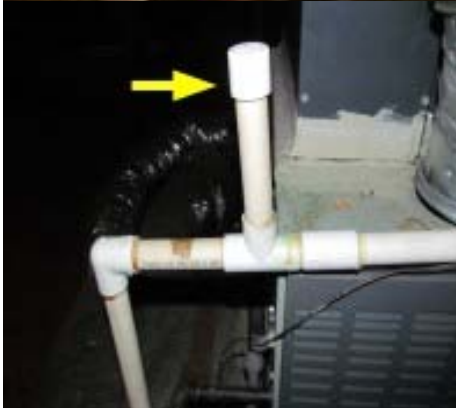
1.11

- 1 . 11 Homebuyer should treat and remove possible algae growth that can plug or restrict the main condensate drain each spring prior to using the A/C system. (Pour a cup of chlorine bleach into the clean out tee followed by 2 gallons of clean water to flush out any possible algae plugs. After treatment the clean out tee should have a removable cap or plug installed so to not loose conditioned air into the attic.)

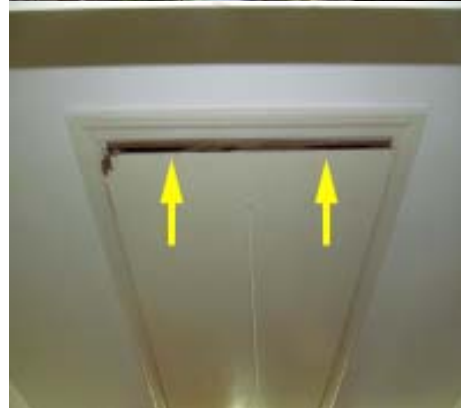
1.13

- 1 . 13    
The attic pull down stair does not close and seal properly and should be repaired to properly close and seal.
- 1 . 14 The A/C systems were allowed to operate continuously for several hours during the inspection. Temperature differential between supply and return register on A/C system did not measure within the normal operating range of 12 to 20 degrees F (see actual test results listed below). A licensed professional HVAC technician should service the system to determine if the refrigerant gas charge is adequate and certify that system is operating properly and as efficiently as possible.    
The upstairs system measured only an 8 degree differential and the downstairs system measured only a 10 degree differential - both systems should be serviced to achieve a more efficient operation.

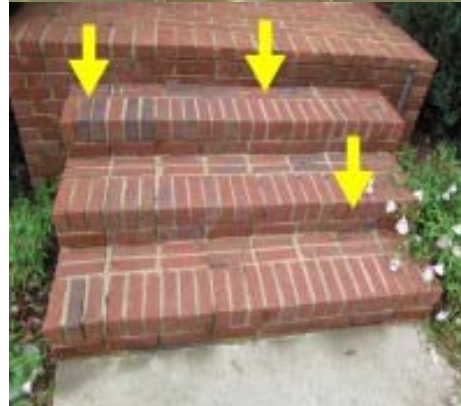
2.2

2 . 2	<p>Brick steps have settled adjacent to the front stoop. This crack and others in these steps should be sealed with flexible caulk to match the mortar color in order to reduce the possibility of freeze damage and additional settling. (Quikrete product 8620 or 8620-09 flexible mortar caulk may be a good choice for small cracks.)</p>	<input checked="" type="checkbox"/>	<input checked="" type="checkbox"/>
2 . 3	<p>A termite bait well system has been installed around the perimeter the dwelling -- Homeowner should request that the termite company transfer any existing termite bond/policy in writing to the Homebuyer. No signs of active termites were observed at the time of inspection. Additionally, it is recommended that the Homebuyer obtain a complete termite inspection, preferably from the company providing any bond, prior to closing; since it is no longer routinely provided by the Seller for real estate transactions in Georgia.</p>	<input checked="" type="checkbox"/>	<input checked="" type="checkbox"/>

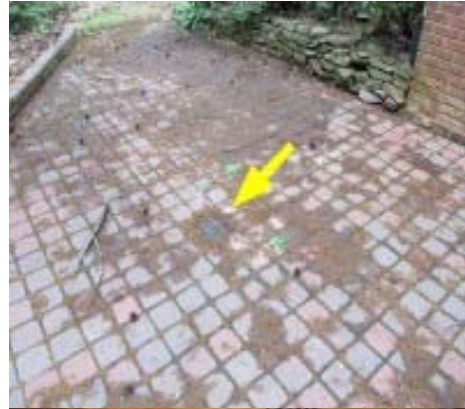
2.4

2 . 4	<p>Brick paver patio near the NW corner of the dwelling appears to be in acceptable condition and a small catch basin drain is installed. Catch basin will likely collect leaves and debris and should be flushed out twice each year.</p>	<input type="checkbox"/>	<input checked="" type="checkbox"/>

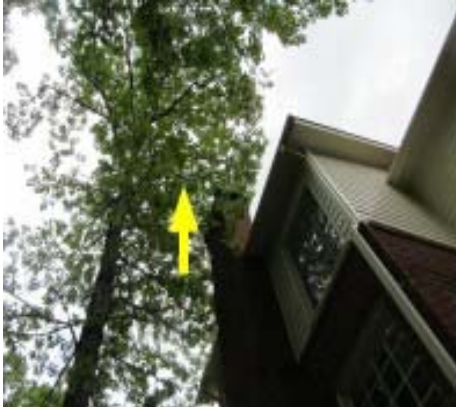
2.5

- 2 . 5 Tree limbs within 6-feet of the dwelling siding, gutters, and/or roof should be cut in order to reduce the possibility of moisture or impact damage during periods of high wind.

- Tree limbs near the rear chimney chase should be cut for required clearance.
- 2 . 6 Elevated deck band joist/ledger board is bolted to structure -- it and the metal joist hangers appear to be secure at the time of inspection. Buyer/Homeowner should periodically monitor joist and ledger board connections for separation cracks and take future corrective action if required.

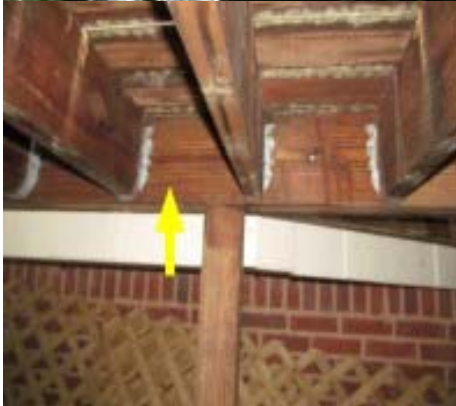
2.7

- 2 . 7    
Same as 2.6 above - except photo of the support posts for the free standing deck under the bay window.
- 2 . 8    
The steps to the deck near the NE corner of the dwelling have settled likely due to improper sloped drainage and water collecting in this area which caused erosion to the retaining wall supporting the steps. Steps have not been properly leveled and it appears that this area is still low and collects water. Additional corrective action is needed to level the steps, repair/secure the retaining wall and divert water away from this area.

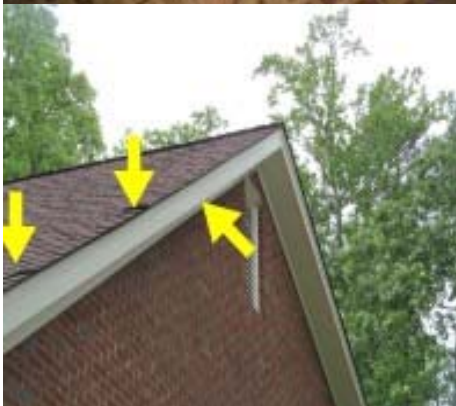
2.9

- 2 . 9    
Architectural grade composite asphalt roof shingles are installed and estimated to be between 4 and 7 years old. Several "nail pops" - nails backing out under the shingles along the East edge of the Garage roof should be repaired and these shingles properly sealed to the roof plane. Also, the paint on this fascia board is weathering and should have any loose and peeling paint removed and properly repainted to protect from moisture damage.

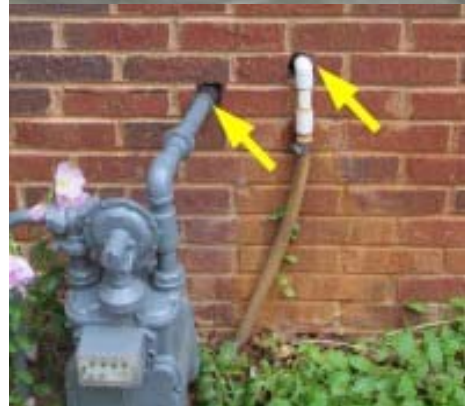
- 2 . 10    
Holes around gas line at the gas meter and the condensate drain on the West brick veneer wall should be properly sealed.
- 2 . 11    
Same as 2.10 above - except hole around the refrigerant gas lines to the A/C condenser units should be sealed and a rain hood installed.

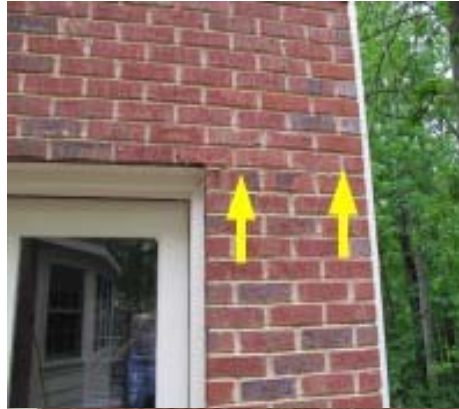
2.12

| | <p>A crack in the brick veneer near the NE double door into the Family Room should be neatly sealed with clear silicone caulk to prevent possible moisture intrusion into the wall cavity. Crack appears to have started at the end of the steel lintel above the door. All ground water should also be diverted away from the brick under the deck to help reduce possible additional settlement. If additional movement occurs - future corrective action may be required to stabilize the brick ledge or footing below.</p> | | |

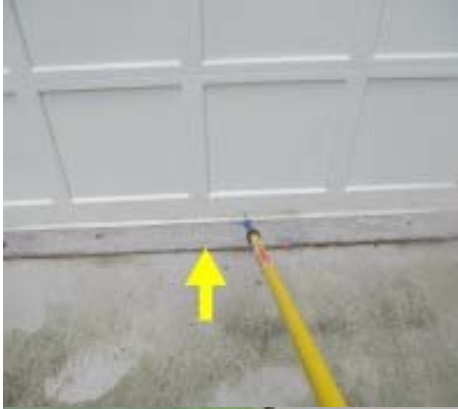
2.13

| | <p>Moisture damaged wood such as fascia boards, windows and door moldings, and/or other wood trim should be replaced -- then properly caulked and painted (small areas can possibly be repaired by using an epoxy based wood hardener (PC-Petrifier or Cure-Rot wood hardeners available at hardware stores or on line <a href="http://www.pcepoxy.com/">www.pcepoxy.com/</a> or <a href="http://www.bg.woodworker.com">www.bg.woodworker.com</a>) and fiberglass wood putty, automotive Bondo, and then painted). The locations listed below have moisture damage and should be repaired.</p> | | |
| | <p>The lower edge of the garage door has moisture damage that should be properly repaired.</p> | | |

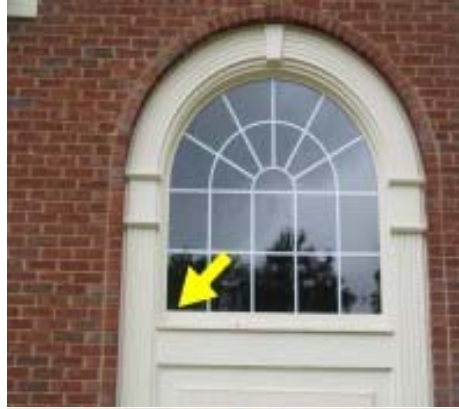
2.14

| | <p>Same as 2.13 above - except the lower West corner of the arched Foyer window has moisture damage that should be properly repaired.</p> | | |

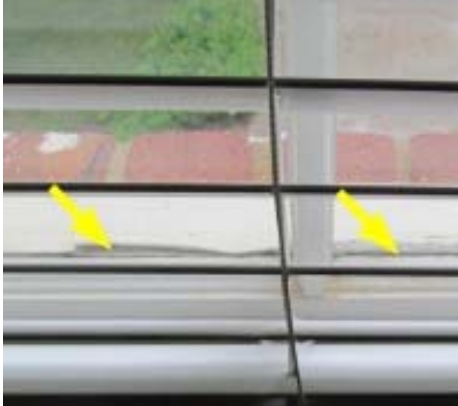
2.15

| | <p>Same as 2.13 above - except Master Bath tub window sill has moisture damage that should be properly repaired.</p> | | |

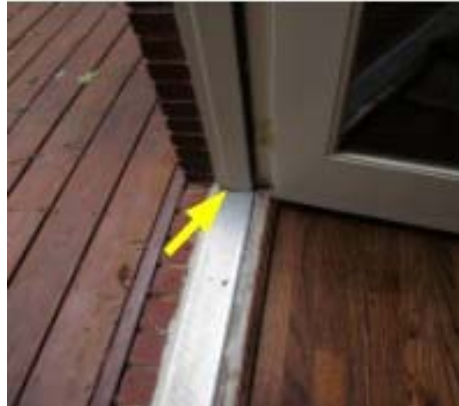
2.16

| | <p>Photo is of the lower corner of the jamb for the East side of the double door onto the deck from the Breakfast area of the Kitchen which shows signs of early moisture damage. All exterior doors should be properly caulked/sealed and painted especially at these lower jamb corners.</p> | | |

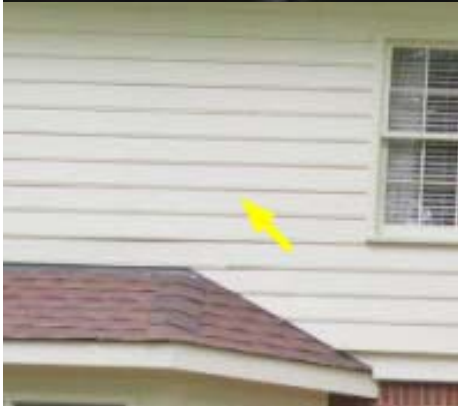
2.17

| | <p>Siding on the rear of the dwelling appears to be in acceptable condition at the time of the inspection and is believed to be a composite wood product since the fiber cement version of the bead board design was not normally being used until the mid 1990's. Regardless of the material type, it appears to be in good condition but should be kept properly caulked and painted to reduce possible future moisture damage.</p> | | |

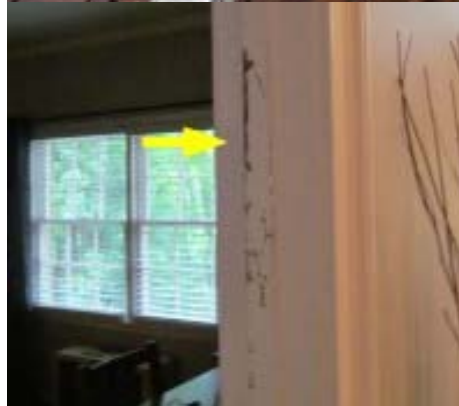
2.18

| | <p>The door frame into the Main level NW bedroom is damaged/scratched and should be properly repaired.</p> | | |

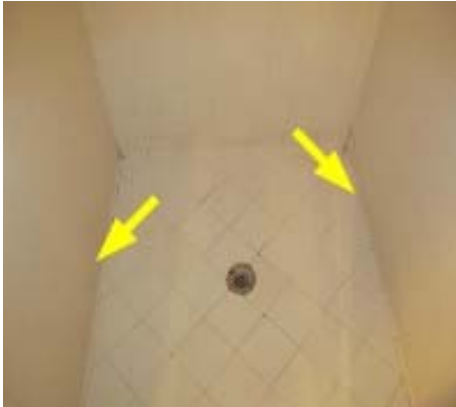
2.19

- 2 . 19    
The lower corners of the Master shower appear to have dark stains that could be mildew that should be properly cleaned. These lower corners should be neatly caulked with a flexible silicone caulk to blend with the tile grout and the tile should be properly regouted.

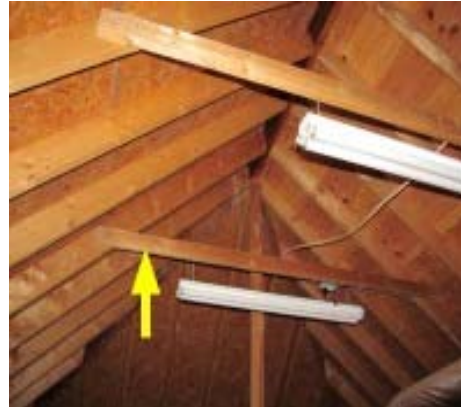
2.20

- 2 . 20    
Attic was entered and the structural framing inspected -- ridge boards appear to be full depth and the rafters properly mitered to the ridge board; collar ties are installed as required by code; purlins are installed at the mid point of rafters and struts are installed down to load bearing walls. Insulation appears to comply with code requirements at the time of construction and no visible signs of roof leaks were found.

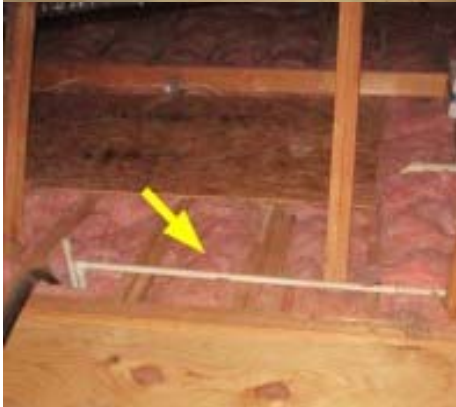
2.21

- 2 . 21    
The majority of the main attic has been decked and the ceiling insulation under this decking was not visible in these areas. However, the areas that were visible appeared to be fiberglass batt insulation approximately 8 to + inches thick as required by code.

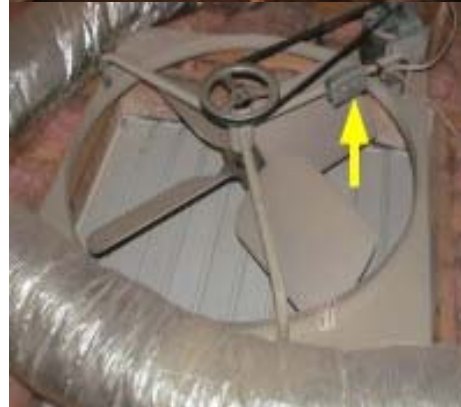
2.22

- 2 . 22    
Whole house fan is equipped with a "fusible link" to stop the operation of the fan in the event of a fire. Also, most whole house fans have a thin metal louver and no insulation above the opening in the ceiling and when the fan is not in use this opening allows significant heat energy to escape in the winter and attic heat to radiate into the dwelling during the hotter months. Whole house fans can waste many hundreds of dollars in utility costs each year due to energy loss. Homebuyer should consider removing the whole house fan, properly closing the hole and properly insulating above the opening.

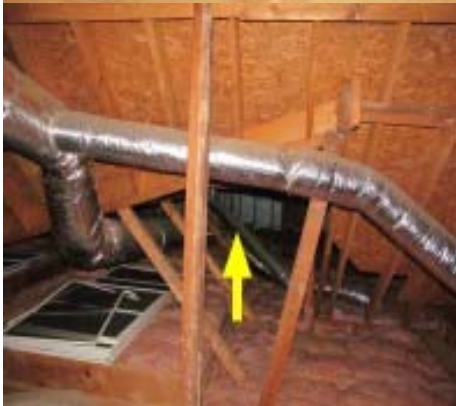
2.23

- 2 . 23    
The attic was entered and areas that were safely accessible were inspected. Due to lack of handholds for inspector's balance or adequate safe room to maneuver; the risk of possible damage to drywall ceilings/dwelling interior was too great to justify inspecting the areas of the attic listed below:

Low attic above the MBR was not entered but inspected from the main attic.
- 2 . 24    
A small door in the Master closet was blocked by stored items and this area was not entered at the time of the inspection.
- 2 . 25    
Refrigerators, ice/water dispensers, clothes washers , dryers , and dryer vent ducts are NOT included as part of a General Home inspection and no warranty for their proper operation is implied or provided. However, as a courtesy to our clients IF a refrigerator is present and is known to remain for the Homebuyer's use, the temperature inside the refrigerator and freezer compartment may be measured and if ice is present in the maker this may be confirmed.  
Refrigerator Temperature / Freezer Temperature / Ice Maker Ice Present  
- 39 degrees F./ 12 degrees F./ Ice was present in the ice maker

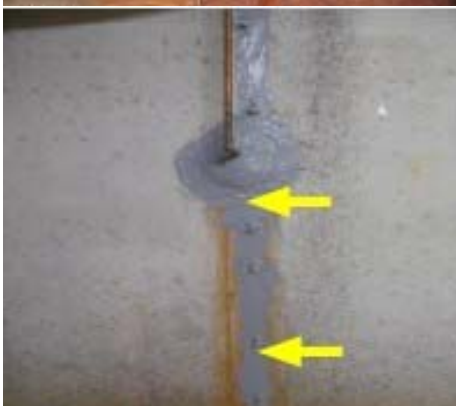
2.26

| <p>Long displacement type cracks appear to be professionally repaired on the South basement retaining wall near the water service line entry into the basement. Typically these repairs have a lifetime warranty which should be transferred to the Homebuyers in writing by the contractor.</p> | | |

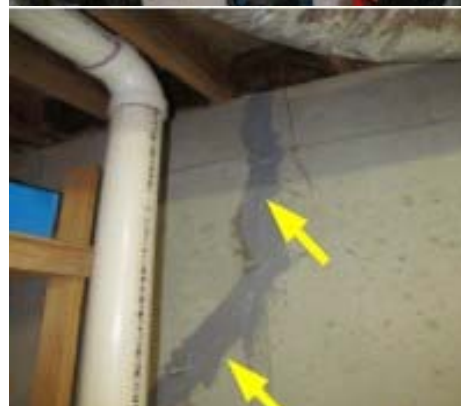
2.27

| <p>Same as 2.26 above - except a photo of an additional crack that has been repaired on the South wall.</p> | | |

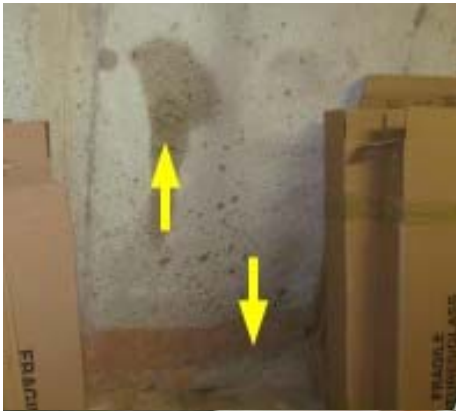
2.28

| <p>The East basement concrete retaining wall near the steps to the deck has moisture stains on the wall and floor. Ground water should be diverted away from this area - see 2.8 above. Even though there has been a significant volume of rain in the last 10-days and no water was found ponding on the floor - the existing Homebuyer should confirm that there is no moisture intrusion into this area.</p> | | |

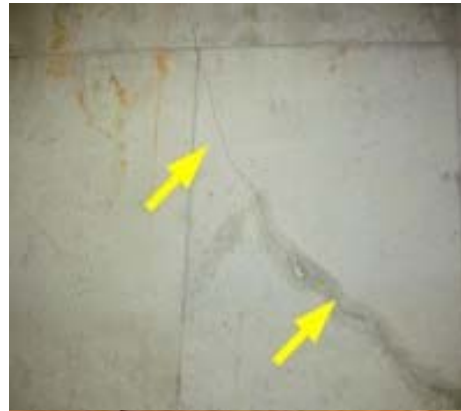
2.29

| <p>Same as 2.28 above - except there is also another crack in the basement retaining wall in this area near the top 1/3 of the wall where there is less hydrostatic pressure. No significant moisture was visible inside the basement at the time of the inspection. Again the existing Homeowner should confirm this crack does not have an active leak. If so, the crack should also be professionally repaired as shown in 2.26 and 2.27 above.</p> | | |

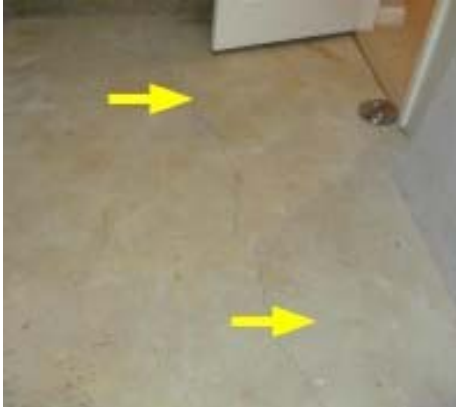
2.30

| <p>Cracks in the basement floating slab are even on both sides of the crack with no signs of settlement at the time of the inspection and are likely curing type cracks. However, cracks should be sealed with clear silicone caulk to prevent moisture/gas/ and insect intrusion.</p> | | |

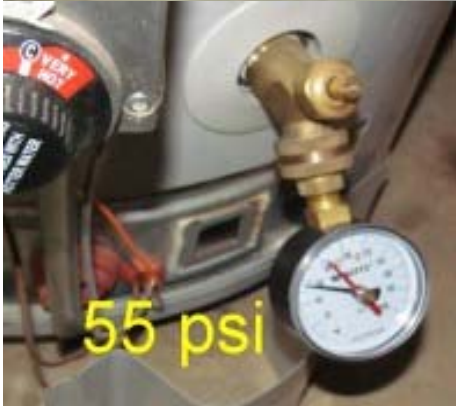
2.32

| <p>Water pressure measured within the normal range at the time of the inspection -- normal interior pressure ranges between 40 to 80 PSI. See photo for the actual pressure measured.</p> | | |

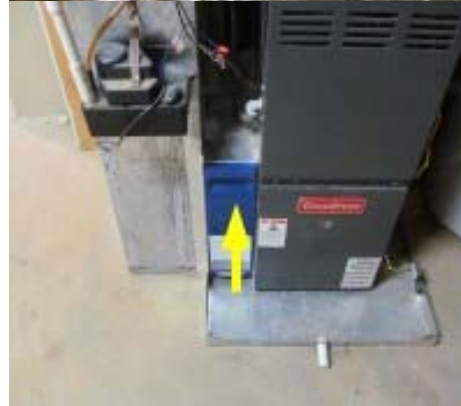
2.33

| <p>HVAC system filters are disposable type filters and should be replaced when dirty. The smaller upstairs system is located in the attic and this filter should be replaced at least every 3-months. Filters are in a filter slot on the exterior of the blower compartment of each HVAC system. The larger HVAC system located in the basement has a large pleated type filter that normally should be replaced at least once per year. Replacement filters are normally available from <a href="http://www.filtersusa.com">www.filtersusa.com</a> for about 1/3 the cost of big box stores.</p> | | |

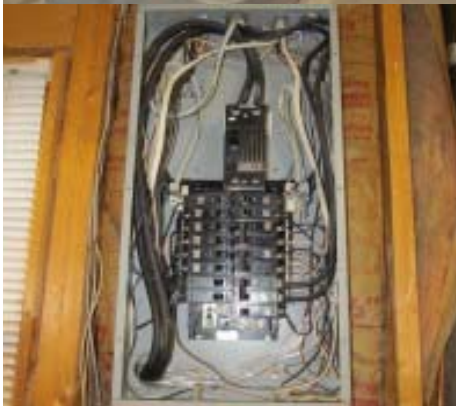
2.34

- 2 . 34    
 The 200-amp 240-volt main electrical distribution panel is located in the basement on the West wall. All 120 volt branch circuit wiring appears to be copper and protected by breakers of the correct current rating. The panel also appears to be adequately grounded.
- 2 . 35    
 A 100-amp 240-volt sub panel is located in the Basement in the East unfinished room. All 120 volt branch circuit wiring appears to be copper and protected by breakers of the correct current rating. The neutral and grounds are properly separated (at the time of inspection).

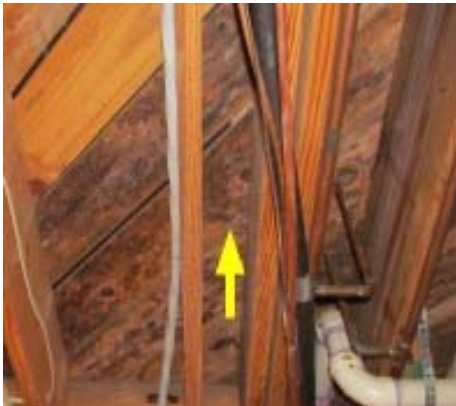
3.1

Line No.	Item Description	Action Needed	See Photo
3 . 1	The majority of the visible sub floor in the basement ceiling has dark stains with possible surface accumulation. These stains are believed to be mold/mildew caused by either/or excessive ambient humidity in the basement above 55% or by the contractor installing green deck boards that were either wet or not properly kiln dried. Since these areas are significant in size and all possibly affected areas may not be visible -- a licensed qualified Industrial Hygienist and a professional qualified remediation contractor experienced in detecting, removing, and eliminating mold should be consulted to confirm that mold is present, to advise of the cost to eliminate any mold, and to test the dwelling to confirm that no air born mold remains after any required remediation is completed.	<input checked="" type="checkbox"/>	<input checked="" type="checkbox"/>

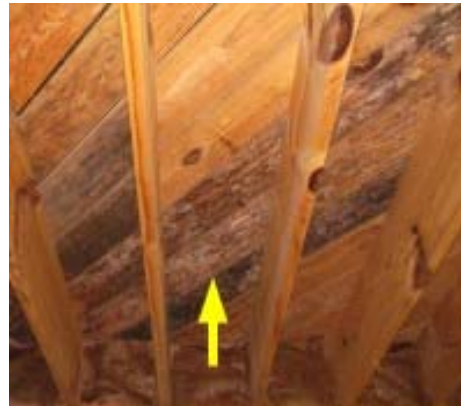
3.2

3 . 2	Same as 3.1 above - except an additional photo of another area in the basement with dark stains on the ceiling.	<input checked="" type="checkbox"/>	<input checked="" type="checkbox"/>
3 . 3	Same as 3.1 above - except an additional photo of another area in the basement with dark stains on the ceiling.	<input checked="" type="checkbox"/>	<input checked="" type="checkbox"/>
3 . 4	Same as 3.1 above - except an additional photo of another area in the basement with dark stains on the ceiling.	<input checked="" type="checkbox"/>	<input checked="" type="checkbox"/>
3 . 5	All electrical receptacles in the basement above bare concrete floors should be GFCI protected and they are not.	<input checked="" type="checkbox"/>	<input checked="" type="checkbox"/>
3 . 6	The circuit legend for the East basement sub panel does not appear to be correct. All circuits in both electrical panels should be properly labeled so that power can be quickly turned OFF in the event of an emergency to any given circuit.	<input checked="" type="checkbox"/>	<input checked="" type="checkbox"/>

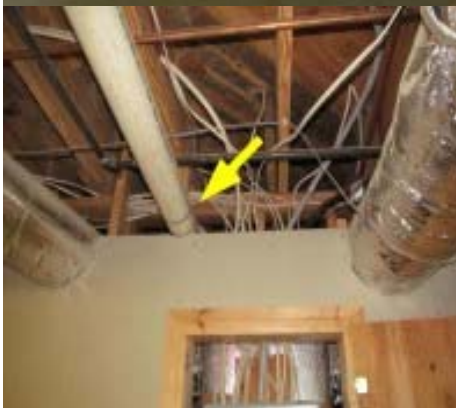
3.7

- 3 . 7    
Romex type wiring into the East Basement sub panel does not appear to be properly separated and stapled as required by code.
- 3 . 8    
As a precaution since the washing machine receptacle is within 6-feet of water it should be GFCI protected and is not.

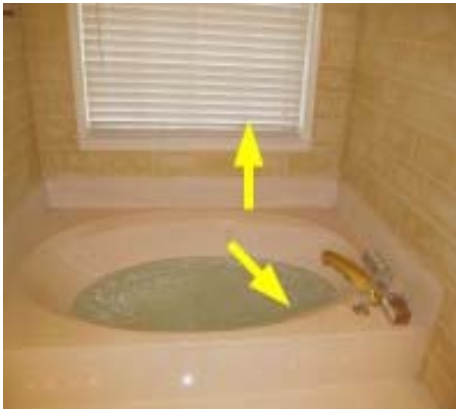
3.9

- 3 . 9    
Window above the garden tub is not marked as being safety or tempered glass suitable for "Human Impact Loads " as required by current codes.

- Also, there is no local air plunger type switch installed in the whirlpool tub to turn the pump ON and OFF while someone is inside the tub. Tub pump is GFCI protected by a breaker in the East basement sub panel and an emergency disconnect switch is provided on the wall of the Master bath; however, as a safety precaution the air plunger type switch should be installed on the wall top curb of the tub.

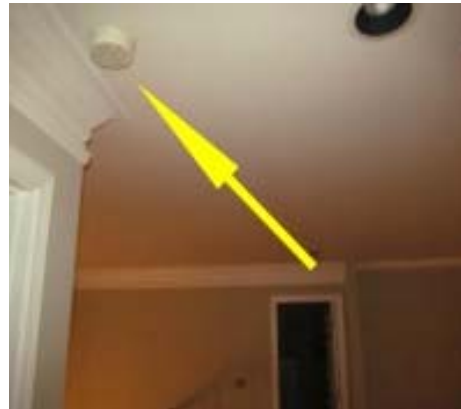
3.10

- 3 . 10    
Smoke detectors at the time of construction were required on each floor of the dwelling and within 10-feet of each bedroom. The detector/alarm for the upstairs area is more than 10-feet from the West bedroom. An additional detector/alarm should be installed. Also, current code requires that an additional detector be installed inside of each bedroom. Homebuyer should consider replacing old design radioactive based detectors with the newer more reliable photo electric design. Radioactive based detectors should be replaced every 5 years since they lose some of their ability to sense smoke. Also, the Homebuyer should install a carbon monoxide detector/alarm on each level of the dwelling.

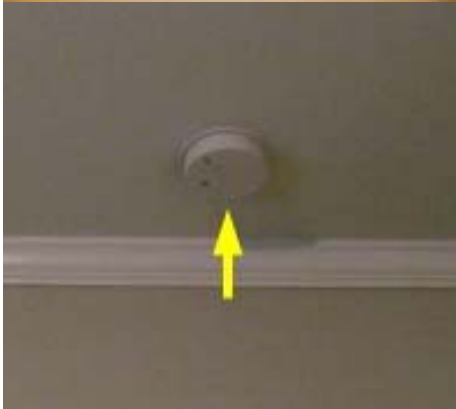
3.11

- 3 . 11    
Same as 3.10 above - except an additional detector/alarm should be installed within 10-feet of the main floor bedroom door in addition to the one installed inside the bedroom door to meet code at the time of original construction.

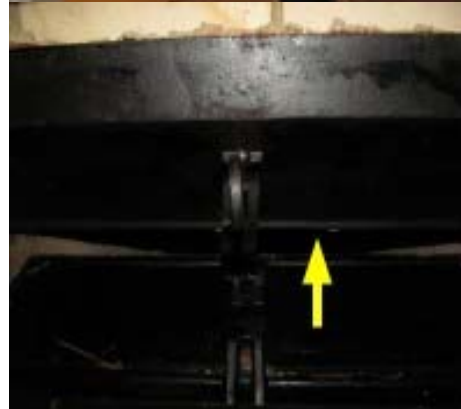
3.12

- 3 . 12    
Gas logs are installed in the Family Room fireplace; however, no damper clamp has been installed to prevent the damper from closing the last 3/4 inch so that combustion gases can vent up the flue but the heat can transfer into the dwelling (and not be lost up the flue). Also, as a precaution both the flue for the basement fireplace and the Family Room fireplace should be professionally cleaned and inspected prior to use by the Homebuyer.

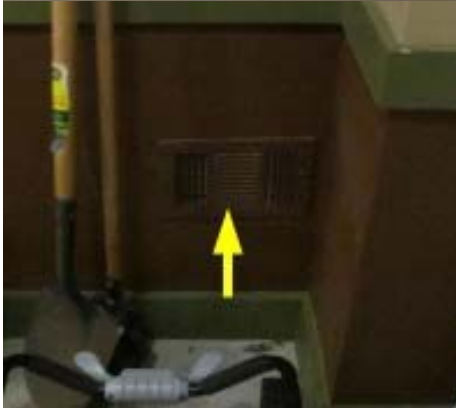
3.13

| | <p>Current codes do not allow a duct opening or a register to be installed in a garage for concern that vehicle gases/carbon monoxide or smoke from a garage fire could flow back into the conditioned dwelling space. Homebuyer should remove the register and seal the duct opening with 26-gage sheet metal.</p> | | |

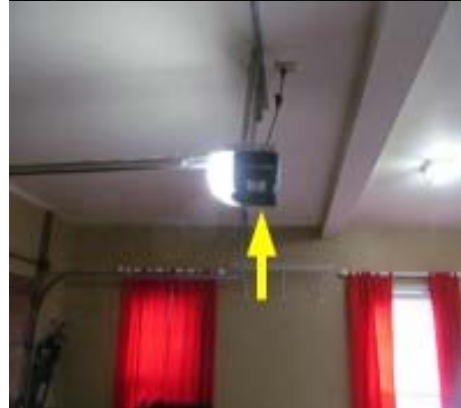
3.14

| | <p>Closing force on automatic garage door opener needs adjustment. Electronic light beam auto reverse IS functioning; however, door does not reverse when on obstruction is placed under door.</p> | | |

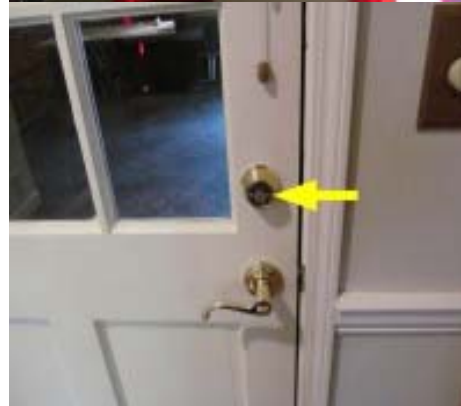
3.16

| | <p>Double cylinder dead bolt locks are a safety hazard and a possible code violation. Interior cylinders should be replaced with thumb levers -- until then a key to each lock should be hung near the lock and made readily available in case of an emergency and the dwelling occupants need to escape.</p> | | |
