New Construction Final Inspection

1234 First Street

Lilburn, GA 30047-5495

Date of Inspection: 6/10/2013

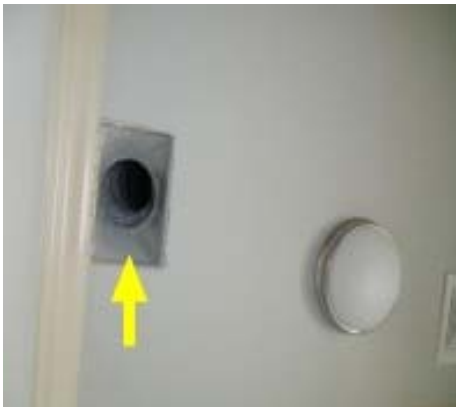
1.1

Line No.	Item Description	Action Needed	See Photo
1 . 1	Missing HVAC register in the Jack and Jill bath should be installed.	<input checked="" type="checkbox"/>	<input checked="" type="checkbox"/>

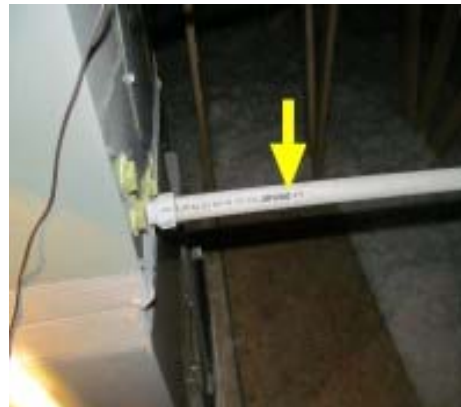
1.2

- 1 . 2 Homebuyer should treat and remove possible algae growth that can plug or restrict the main condensate drain each spring prior to using the A/C system. (Pour a cup of chlorine bleach into the clean out tee followed by 2 gallons of clean water to flush out any possible algae plugs. After treatment the clean out tee should have a removable cap or plug installed so to not loose conditioned air into the attic.)

- No clean out tee with a removable cap has been installed for the A/C system located in the attic and one should be installed. Basement system has a clean out tee.

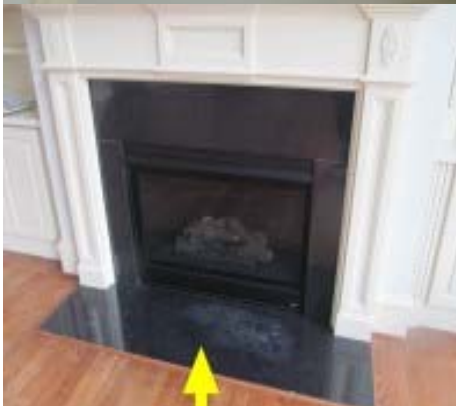
1.3

- 1 . 3 Gas log Heat-a-lator was not operating at the time of the inspection. This unit has a control valve system that is of a new design and the Builder should explain to the Homebuyer how to properly operate this unit.

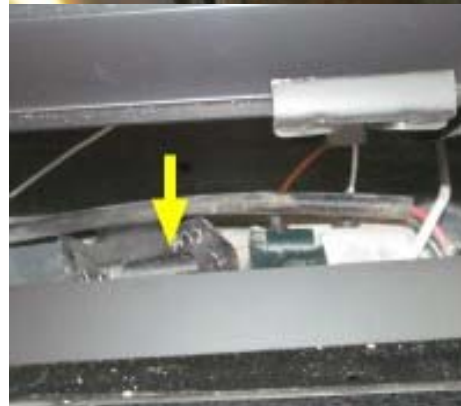
1.4

- 1 . 4 Same as 1.3 above - except photo of a battery holder under the gas logs that is designed to hold two D-Cell batteries which have not been installed.

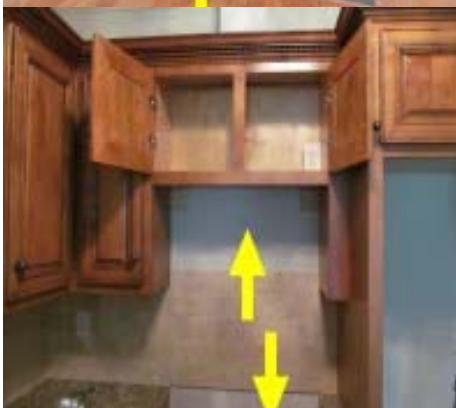
1.5

- 1 . 5 The microwave for the basement Kitchen and the oven were not installed at the time of the inspection and could not be tested.
- 1 . 6 The dishwasher for the basement Kitchen was blocked by the large oven temporarily placed in front of it and this dishwasher was could not be opened and tested at the time of the inspection.

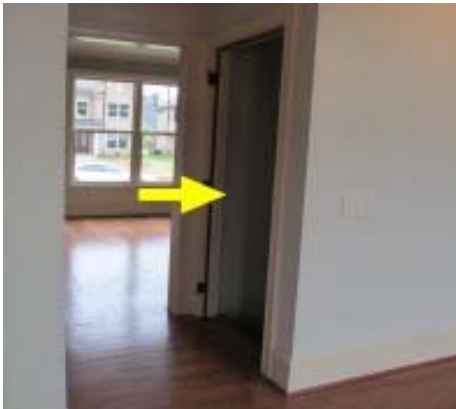
1.7

- 1 . 7 The door at the top of the basement stairs has been removed at the time of the inspection and could not be tested.
- 1 . 8 Missing light fixture globe in the Master Bath closet should be installed.

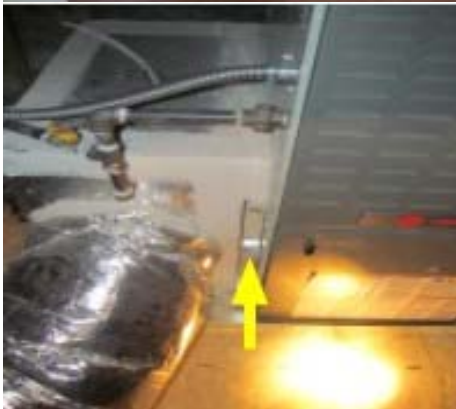
1.9

- 1 . 9 HVAC system filters are disposable type filters and should be replaced when dirty or at least every 3-months. Filters are in a filter slot on the exterior of the blower compartment of each HVAC system.

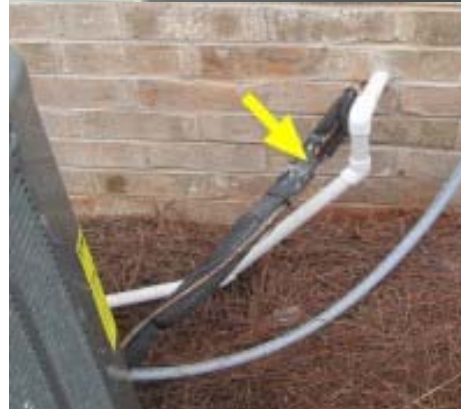
1.10

- 1 . 10 Damaged foam sleeve insulation for the cold gas lines near the exterior A/C condenser units should be replaced and all of the cold gas lines should be properly covered and insulated.

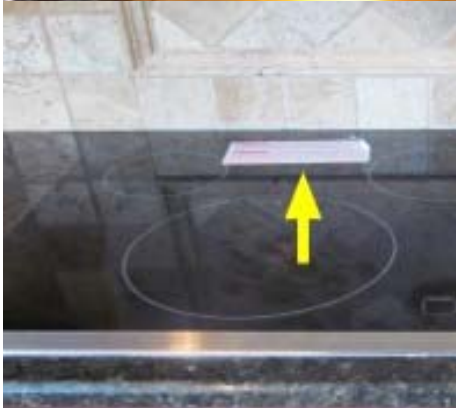
1.11

- 1 . 11 A gummed type label has not been removed from the electric cook top and should be prior to testing the cook top since it might damage the finish if the unit gets hot before it is removed. Inspector did not test the cook top at the time of the inspection.

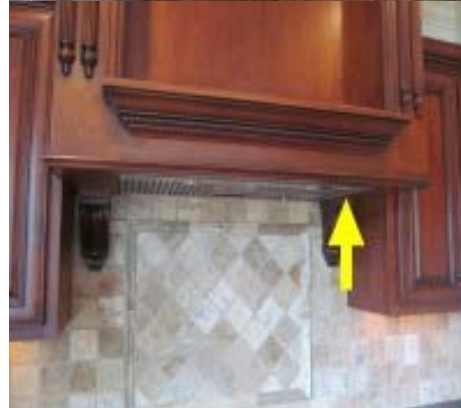
1.12

| | <p>Two separate general purpose counter top circuits have been provided in the Kitchen; however, the exhaust fan above the cook top has been connected to one of these counter top circuits and that is contrary to the 2011 NEC, Article 210.11C and 210.52B, (2) "No Other Outlets. The two or more small-appliance branch circuits specified in 210.52(B)(1) shall have no other outlets." A separate circuit with a properly sized breaker should be provided for the exhaust fan.</p> | | |

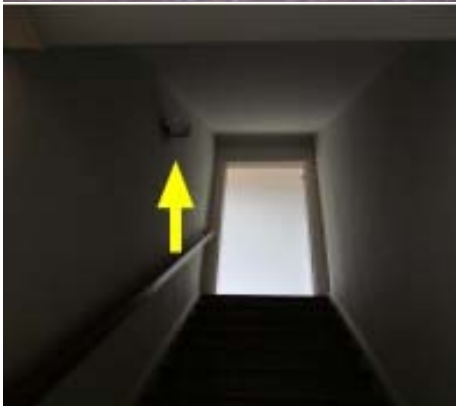
1.13

| | <p>The light fixture in the basement stairway was not operating at the time of the inspection and should be repaired or have the lamps replaced.</p> | | |

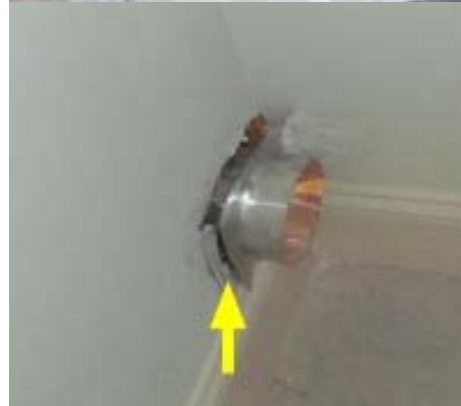
1.14

| | <p>The upstairs dryer vent appears to have missing or damaged insulation around the metal duct which should be replaced and then the cover plate should be properly secured.</p> | | |

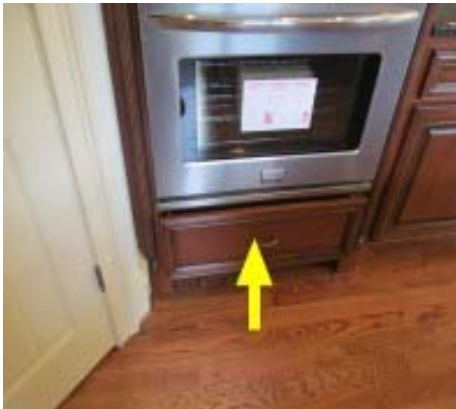
1.15

| | <p>The drawer under the main Kitchen oven does not stay closed and should be adjusted to remain closed.</p> | | |

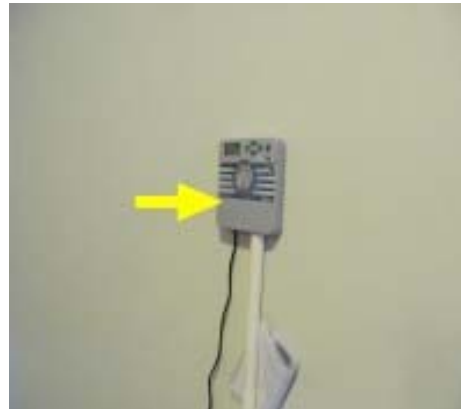
1.16

| | <p>The existing Homeowner should demonstrate to the Homebuyer -- how the lawn sprinkler system is set up, what are the optimum cycle times and why, and confirm that all zones are operating properly. (Since each lawn sprinkler system is unique, it usually requires a minimum of two people 45 minutes to properly test a system and this is not included as part of a general home inspection.)</p> | | |

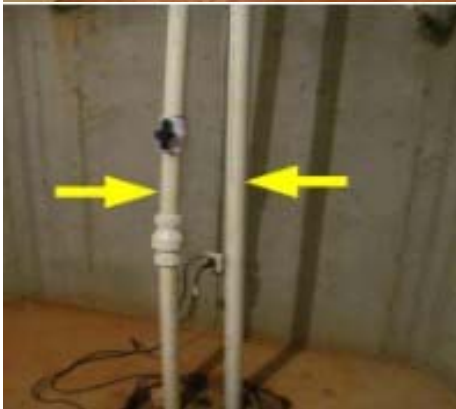
1.17

| | <p>The long vertical risers from the grinder pump up to the ceiling of the basement are not properly supported and move when the pump discharges. Pipes should be properly supported or at least strapped together to reduce movement and reduce possible loosening of the check valve connections.</p> | | |

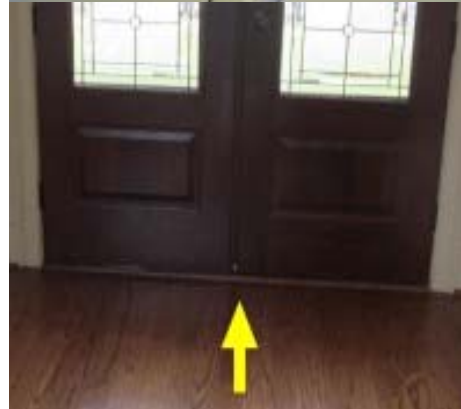
1.18

| | <p>A small light leak at the center bottom between the double front doors should have the weather stripping repaired to prevent energy loss and insect intrusion.</p> | | |

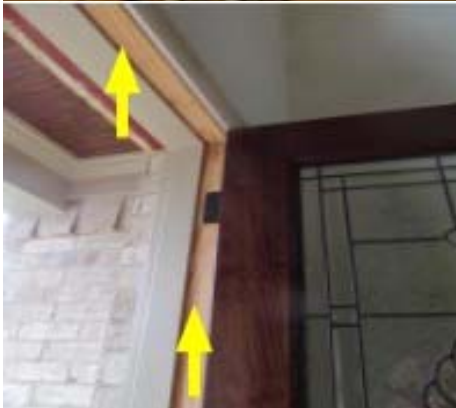
1.19

| | <p>The unfinished wood around the inside of the front door jamb should be properly finished and then the missing weather stripping should be installed.</p> | | |

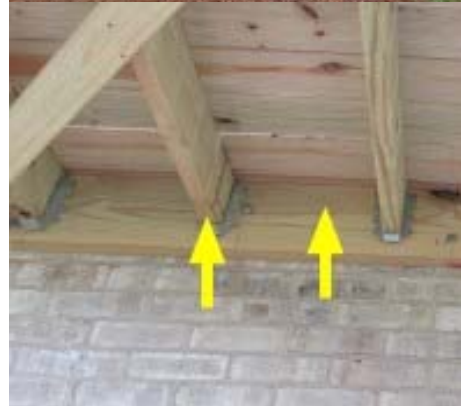
2.3

- 2 . 3 Elevated deck band joist/ledger board is bolted to structure -- it and the metal joist hangers appear to be secure at the time of inspection. Buyer/Homeowner should periodically monitor joist and ledger board connections for separation cracks and take future corrective action if required.

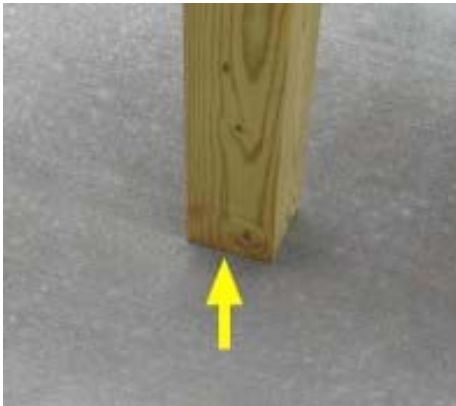
2.4

- 2 . 4
Not all of the deck and stair support posts are secured to the slab and should be.
- 2 . 5
Deck should be stained within the next 6 months once the pressure treatment chemicals stop leaching out of the new wood.

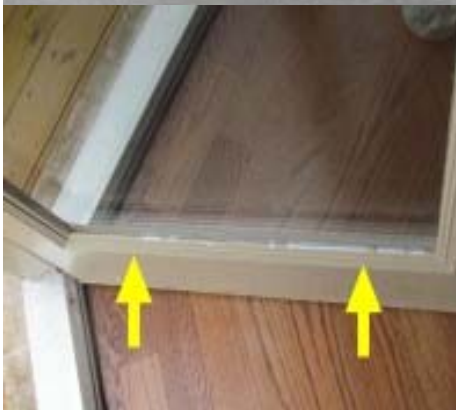
2.6

- 2 . 6
Damaged exterior painting around the doors to the deck from the Breakfast area of the Kitchen should be properly repaired.
- 2 . 7
Caulking may shrink with time and the Homebuyer should keep the openings exterior wall for the A/C service piping properly caulked and sealed.
- 2 . 8
Steel lintels have been primed at the time of construction and have moderate rust at the time of inspection -- however, finish paint should be applied to all lintels (to match the brick or trim color) in order to prevent the lintels from corroding, expanding, and eventually splitting the mortar joints.
- 2 . 9
Same as 2.8 above - except an additional photo.
- 2 . 10
Large gap under the exterior power meter and main breaker cabinet should be properly filled/sealed.

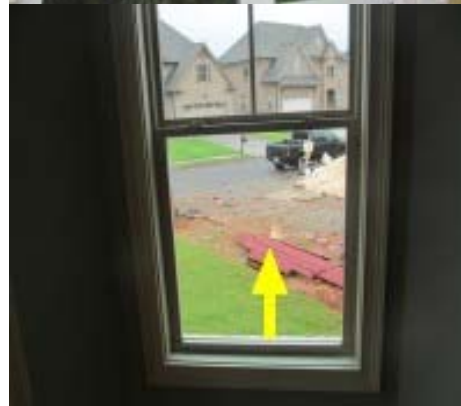
2.11

- 2 . 11
Builder should confirm that the dwelling conforms to the 2009 International Energy Conservation Code and the following minimum energy code ratings will be met or demonstrate the allowed trade offs. Stud walls = R-13, Ceiling = R30, Windows U-Factor 0.55 -- Solar Heat Gain Coefficient = 0.40, NFRC or default label = 102.5.2 A/C condenser units meet a minimum SEER rating of 13, etc. -- (This information is needed for the Homebuyer's records for future home inspections.)

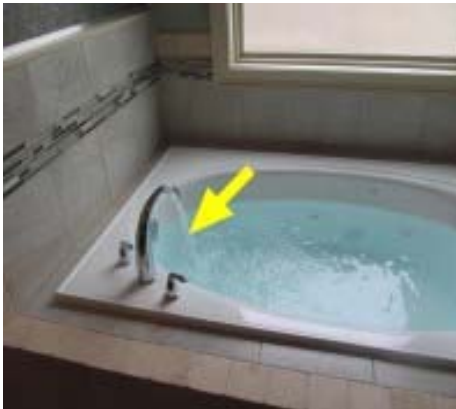
2.12

- 2 . 12
Bath tubs (above finished areas of the dwelling) were filled and water allowed to enter the overflow drain to test for leaks -- none were found at the time of the inspection. However, Homebuyer should examine the ceilings (if accessible) under these tubs over the next several days to verify there are no small water spots from small leaks. Also once the overflow drain test was completed the tub stopper was released to test the main tub drain flow.

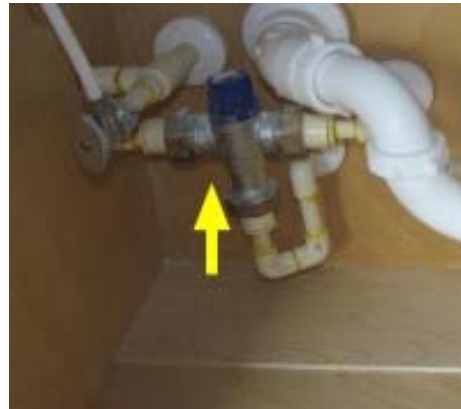
2.13

- 2 . 13
A thermal mixing valve is installed for the Master tub as required by code. The valve is located under the counter in the Master bath.
- 2 . 14
A chip on the enamel finish of the downstairs bath tub should be professionally repaired so that the tub can be properly cleaned and sanitized.

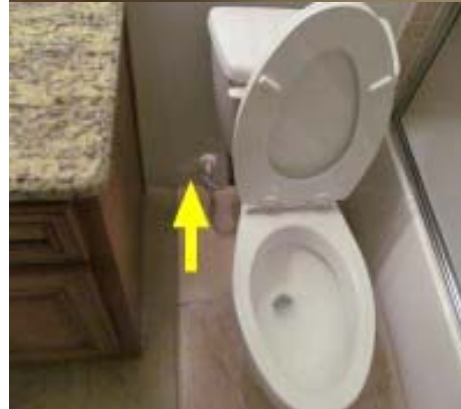
2.15

- 2 . 15
Several sheet rock and paint defects were observed through out the dwelling -- however, Buyer shall list all cosmetic items and furnish a separate list to the Builder probably at the time of the Final Walk Through.
Missing baseboard and trim around the basement bath toilet should be installed and properly painted.

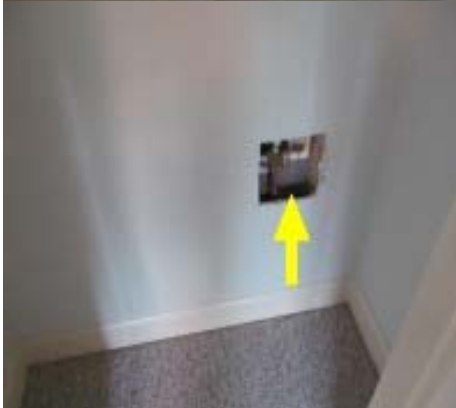
2.16

- 2 . 16
Same as 2.15 above - except access hole in the basement bedroom closet behind the tub faucet should be properly closed with drywall or a plastic pop out access panel should be installed.

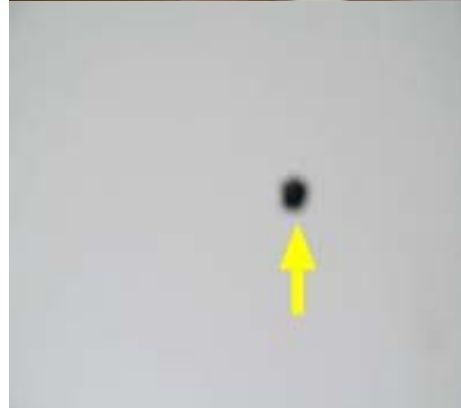
2.17

- 2 . 17
Same as 2.16 above - except hole in the ceiling of the Basement Family room should have a suitable access cover installed.
- 2 . 18
Same as 2.15 above except numerous ceilings have been touched up and the finish is not complete and should be.

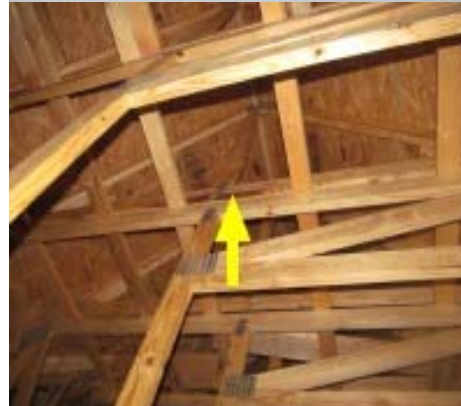
2.19

- 2 . 19 Roof support structure system is 2X4 trusses -- trusses appear to be installed vertically, no loose connection plates were visible, no field cuts and no broken cords were found. Homebuyer should store only light weight items that heat will not damage in the attic and limit the weight of any items stored in the attic in order to not damage the trusses. Truss roof systems are designed to support ONE layer of roof shingles, the roof decking, and the dry wall ceilings below.

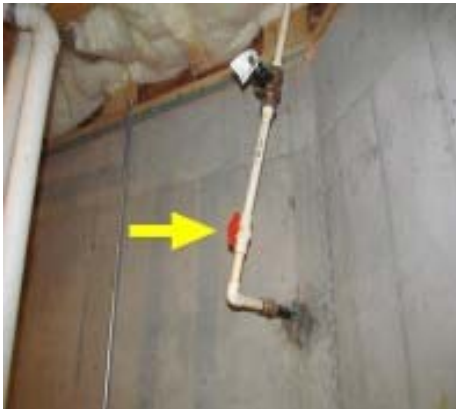
2.20

- 2 . 20
Photo of the Main water Shut OFF valve in the basement utility room.
- 2 . 21 The electrical distribution panel is located in the Basement. All 120 volt branch circuit wiring appears to be copper and protected by breakers of the correct current rating. The neutral and grounds are properly separated (at the time of inspection).

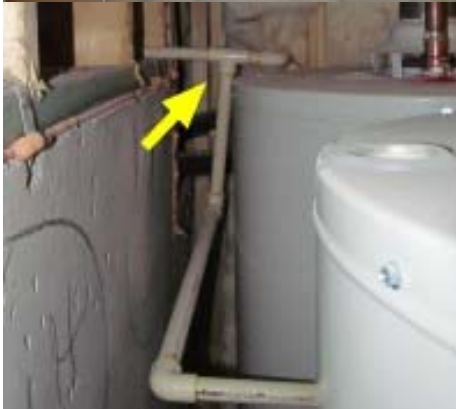
3.1

Line No.	Item Description	Action Needed	See Photo
3 . 1	The 3/4 in diameter discharge pipes for the water heater Pop OFF or TPV life safety devices have not been installed as required by codes and the manufacturer's installation instructions. The discharge lines have more than 4 each 90 degree elbows AND the lines are NOT separated to the dwelling exterior as required by Georgia Amendments to the 2006 International Plumbing code. The Amendment reads -- "*Delete Section 504.6 'Requirements for discharge piping' and substitute the following: 504.6 Requirements for discharge piping. The relief valve shall discharge full size, separately to a safe place of disposal such as a concrete floor, outside the building, an indirect waste receptor, or other approved location. The discharge shall terminate in a manner that does not cause injury to occupants in the immediate area or structural damage to the building. When the relief valve discharge piping goes upward, a thermal expansion control device shall be installed on the cold water distribution or service pipe in accordance with Section 607.3.2. If the discharge pipe is trapped, provisions shall be made to drain the low point of the trapped portion of the discharge pipe."	<input checked="" type="checkbox"/>	<input checked="" type="checkbox"/>

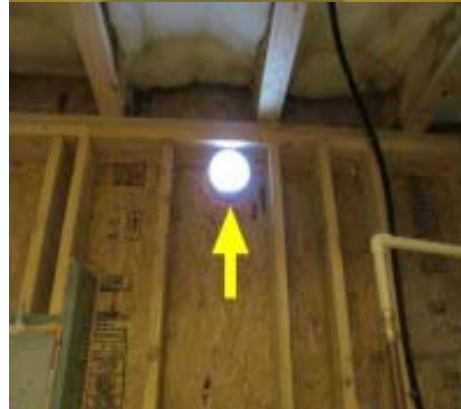
3.2

Two 40,000 Btu water heaters and one 80,000 Btu furnace are installed in the sealed basement utility room and only one small combustion air vent is provided. A minimum of two combustion air vents are required by code - one a minimum of 12-inches from the top and one a minimum of 12-inches from the bottom of the utility room floor are required. Also these openings must be sized correctly for a minimum of the 160,000 Btu's of appliances installed in this utility room (8 in. diameter minimum?). The 2006 International Residential Code, Section M1703.1 for Outdoor air states. "Where the space in which fuel-burning appliances are located does not meet the criterion for indoor air specified in Section M1702, outside combustion air shall be supplied as specified in Section M1703.2. M1703.2 Two openings or ducts. Outside combustion air shall be supplied through openings or ducts, as illustrated in Figures M1703.2(1), M1703.2(2), M1703.2(3) and M1703.2(4). One opening shall be within 12 inches (305 mm) of the top of the enclosure, and one within 12 inches (305 mm) of the bottom of the enclosure. Openings are permitted to connect to spaces directly communicating with the outdoors, such as ventilated crawl spaces or ventilated attic spaces. The same duct or opening shall not serve both combustion air openings. The duct serving the upper opening shall be level or extend upward from the appliance space. Section M1703.2.1 Size of openings. Where directly communicating with the outdoors, or where communicating with the outdoors by means of vertical ducts, each opening shall have a free area of at least 1 square inch per 4,000 Btu/per hour (550 mm²/kW) of total input rating of all appliances in the space. Where horizontal ducts are used, each opening shall have a free area of at least 1 square inch per 2,000 Btu/per hour (1100 mm²/kW) of total input of all appliances in the space. Ducts shall be of the same minimum cross-sectional area as the required free area of the openings to which they connect. The minimum cross-sectional dimension of rectangular air ducts shall be 3 inches (76 mm).

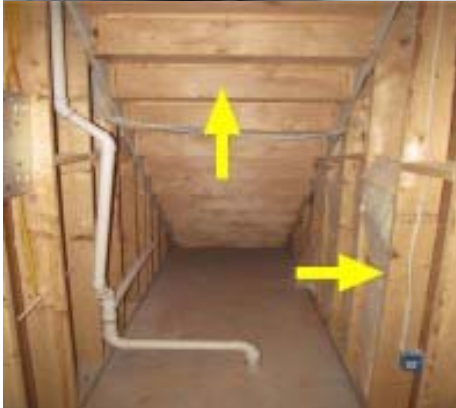
3.3

Section R311.2.2 of the 2006 IRC states "Under stair protection. Enclosed accessible space under stairs shall have walls, under stair surface and any soffits protected on the enclosed sidewith 1/2-inch (13 mm) gypsum board.

No fire rated drywall is installed under the basement stairs and should be as required by codes.

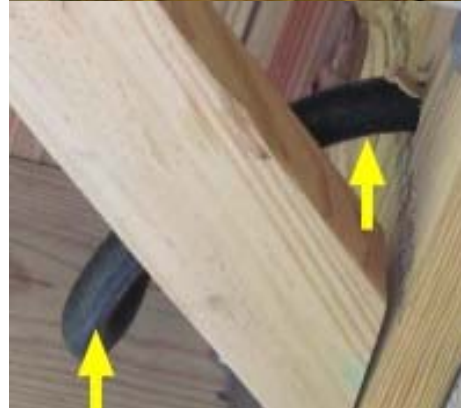
3.4

Approximately 12 inches of a black plastic or rubber wrapped gas line is visible going to the elevated deck gas grill connection. This short section was not enough length for this inspector to view any markings on the exterior of this tubing material used for this gas service. Builder should confirm if this is black plastic wrapped CSST (corrugated stainless steel tubing) suitable for exterior gas line service use (which is wrapped to protect it so that it can penetrate through the exterior wall and deck framing).

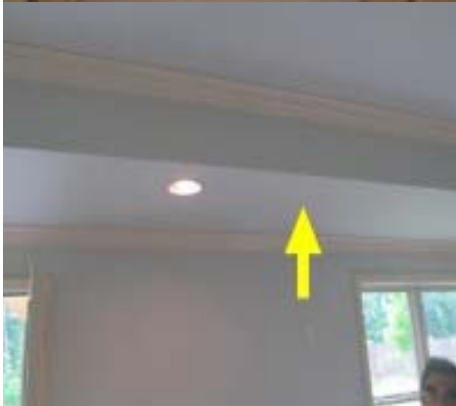
3.5

- 3 . 5
Same as 3.4 above - except additional photo of where the Homebuyer indicates the black flexible gas pipe terminates above the drywall ceiling in the Basement Family Room.

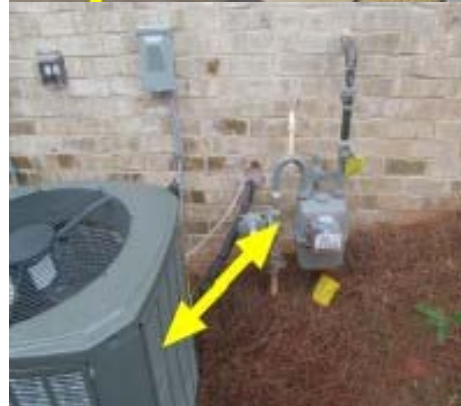
3.6

- 3 . 6
Gas meter should have been installed so that the Pressure Regulating Valve, that has a small vent opening under the valve that vents excessive pressure gas, should be relocated to be at least 36-inches clearance from any possible electrical ignition source such as an A/C condenser unit. Gas meter should be relocated to achieve the required clearance. (Also see attachment "gasmeter.pdf" where some municipalities publish a specification sheet to clarify these code requirements.)

- Section 3403 of the 2006 International Fire Code, Table 3403.1.1 states "Class I Electrical Equipment Locations ... Outdoor equipment where flammable vapor/air mixtures COULD exist under normal operations ... Area within 3 feet of any edge of such equipment, extending in all directions." and the National Electrical Code Article 500.5 (B) further defines that any equipment installed within these areas be designed to meet a Class I hazardous locations and most A/C condensers are not. Per the NEC "Class I Locations are those in which flammable gases or vapors are or may be present in the air in quantities sufficient to produce explosive or ignitable mixtures. Class I locations shall include those specified in the 500.5(B)(1) and (B)(2). (1) Class I, Division 1, A Class I, Division I location is a location (1) in which ignitable concentrations of flammable gasses or vapors can exist under normal operating conditions or ... (10) All other locations where ignitable concentrations of flammable vapors or gases are likely to occur in course of normal operations."

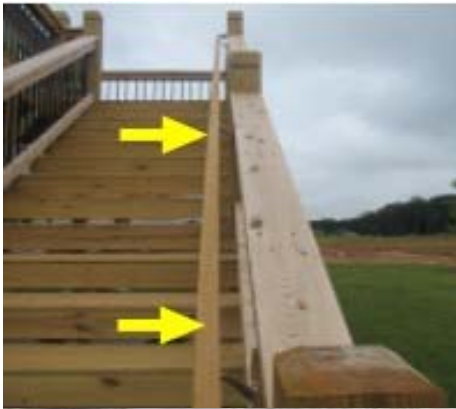
3.7

- 3 . 7
The hand rail for the deck stairs is not round and the corners are very sharp and have splinters. Handrail should be properly sanded to eliminate the sharp edges and possible splinters that could be a puncture wound hazard.

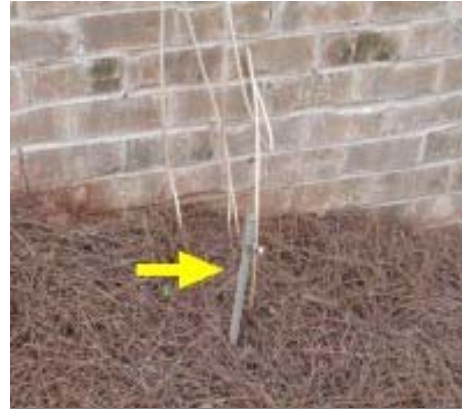
3.8

- 3 . 8 A "Ufer" type grounding connection has been made for the main electrical ground for lighting protection on the rebar in the location listed below. Since the National Electrical Code requires that all electrical connections be accessible - Homebuyer should have an access door installed in the wall to allow the connections to be inspected/checked IF this area is finished in the future. Only one driven ground rod is visible on the South side of the dwelling near the power meter. NEC codes require either two grounding electrodes to be driven a minimum of 8-feet into the earth space approximately 6-feet apart OR that a Ufer type grounding connection be made to the rebar embedded in the poured concrete basement retaining wall. Builder should confirm that either a second ground rod has been installed or that a Ufer connection has been made and locate this connection for the Homebuyer. Connection should be left accessible. Also, the ground rod should be driven flush with the grade to assure that its entire 8-ft. length has contact with the earth as required by code and to eliminate a possible impale hazard for children.

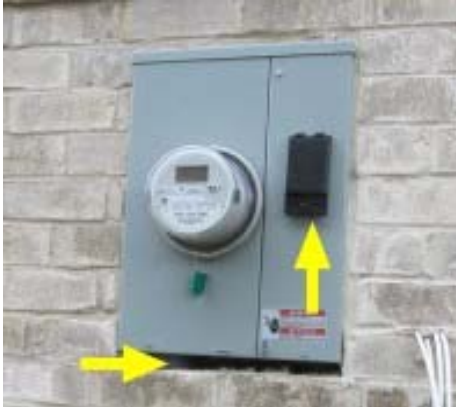
3.9

- 3 . 9 Main electrical breaker is located on an outside wall next to the power meter. For security purposes Buyer/Homeowner should consider installing a padlock on the breaker cabinet and hanging the key inside in a readily accessible location in case of emergency.

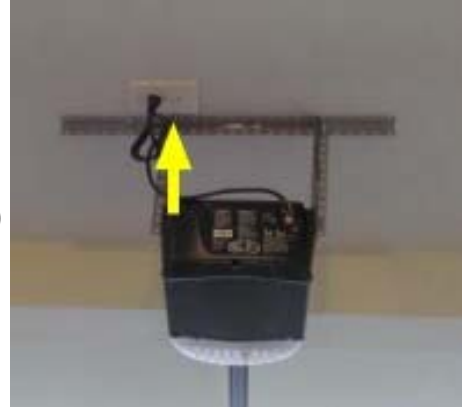
3.10

- 3 . 10 The 2011 NEC (National Electrical Code) requires that Ground Fault Circuit Interrupters be provided for the garage ceiling receptacles used for automatic door openers or cord reels as specified in Sections 210.8 (A), (B) and (C) - these GFCI devices also must be installed in a readily accessible location as defined by Article 100 of the NEC. Readily accessible GFCI protection should be provided for the garage door openers as required by code.

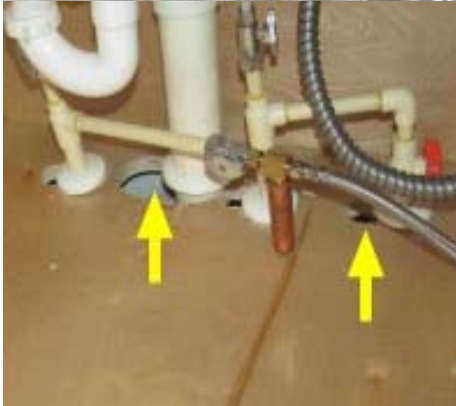
3.11

- 3 . 11 Very large holes have been cut for the plumbing lines in the lower shelves under the Kitchen sinks. These holes should be properly sealed with metal flashing and foam to prevent stored items from falling into the holes under the shelf and to reduce the possibility of pest infestation.

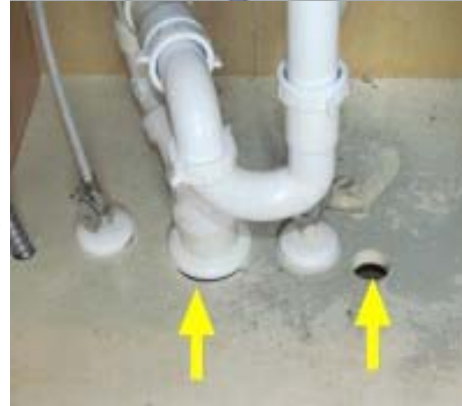
3.12

- 3 . 12 Same as 2.11 above - except an additional photo of the small vegetable sink in the Kitchen that also has large holes that should be closed and sealed.

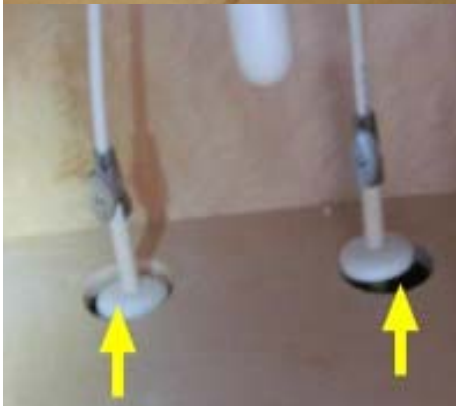
3.13

- 3 . 13 Same as 2.11 above - except an additional photo of bath room sinks that should also have large plumbing holes properly closed and sealed.
