# Home Inspection

**Mr. Charles R. Smith**

**1234 First Street**

**Date of Inspection: 5/6/2013**

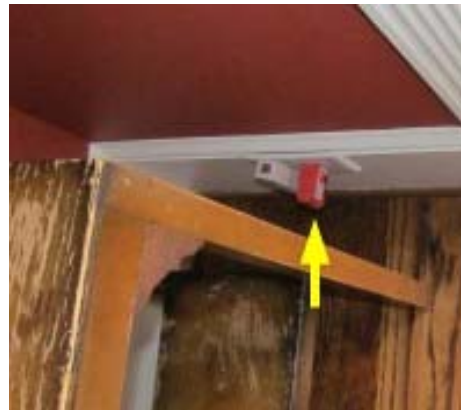
1.3

| 1 . 3 | Front doorbell was not operating at the time of the inspection and should be repaired. Also, the rain proof cover for the front door electrical receptacle is loose and should be properly secured and sealed to prevent water intrusion. | <input checked="" type="checkbox"/> | <input checked="" type="checkbox"/> |
