New Construction Final Inspection

1234 First Street

Lilburn, GA 30047-5495

Date of Inspection: 6/10/2013

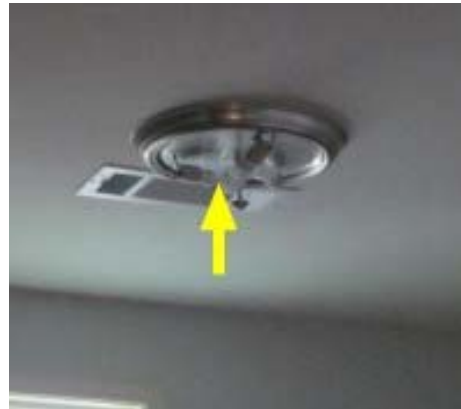
1.8

- 1 . 7 The door at the top of the basement stairs has been removed at the time of the inspection and could not be tested.
- 1 . 8 Missing light fixture globe in the Master Bath closet should be installed.
